Access Compliance Report

Public Rights-of-Way

(Curb Ramps)

Intersection ID: 24081	Main Street: PRESCOTT_POND_LN	Cross Street: SHARPTHORNE_PL	Location: NE
ADA ID: 144ED1E96425	Ramp Type: PerpDiag	Initial Pass/Fail: Fail	Overall Compliance: No
Severity Score: 33.75			
Codes/Mitigation Info/Possible Solution		Field Measurements/Component Compliance

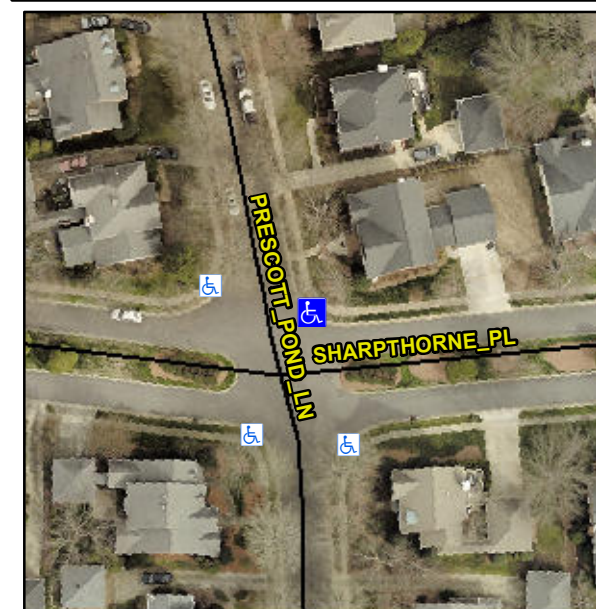
PROW/ADA:

Not Found, R304.5.1, R304.2.2, R304.5.3

Compliance	Description	Data	Compliance	Description	Data
N/A	Ramp Length (in)	46.0	No	Ramp Slope (%)	11.3
No	Ramp Width (in)	47.5	No	Ramp XSlope (%)	5.7
N/A	Flare Type LT	N/A	N/A	Flare Type RT	N/A
N/A	Flare Slope LT (%)	N/A	N/A	Flare Slope RT (%)	N/A
N/A	Flare Traversable LT?	N/A	N/A	Flare Traversable RT?	N/A
N/A	Landing Length (in)	N/A	N/A	DWS Provided?	N/A
N/A	Landing Width (in)	N/A	N/A	DWS Contrast?	N/A
N/A	Landing Slope (%)	N/A	N/A	DWS Length (in)	N/A
N/A	Landing X Slope (%)	N/A	N/A	DWS Full Width?	N/A
N/A	Landing Curb? (Y/N)	N/A	N/A	DWS Offset (in)	N/A
N/A	Shared Landing?	N/A			
N/A	Gutter Ponding?	N/A	N/A	Gutter Slope (%)	N/A
N/A	Gutter Lip Ht (in)	N/A	N/A	Gutter X Slope (%)	N/A
N/A	Painted X Walk1?	No	N/A	Painted X Walk2?	No
	X Walk 1 Direction	To W		X Walk 2 Direction	To S
N/A	X Walk 1 Width (in)	N/A	N/A	X Walk 2 Width (in)	N/A
	X Walk 1 Slope (%)	0.5		X Walk 2 Slope (%)	4.3
	X Walk 1 X Slope (%)	5.1		X Walk 2 X Slope (%)	2.8

N/A	Ramp inside XWalk1?	N/A	N/A	Ramp inside XWalk2?	N/A
	Road Slope (%)	5.8	N/A	Clear Space?	N/A
	Road X Slope (%)	3.6	N/A	Clear Space to XWalk (in)	N/A
N/A	Any Obstructions?	N/A	N/A	Storm Grate/Utility Hazard?	N/A
	Obstruction Type			Storm Grate/Utility Type	
		N/A			N/A
			Yes	Surface Condition? (G/P)	Good

Possible Solutions:

Remove & Replace Curb Ramp With Two New Directional Ramps or Equivalent.
