Access Compliance Report

Public Rights-of-Way

(Curb Ramps)

Intersection ID: 54218	Main Street: GOLF_LINKS_DR	Cross Street: SANDY_ROCK_PL	Location: SW
ADA ID: 145AB8F7BBAB	Ramp Type: Directional1	Initial Pass/Fail: Fail	Overall Compliance: No
		Severity Score: 1.25

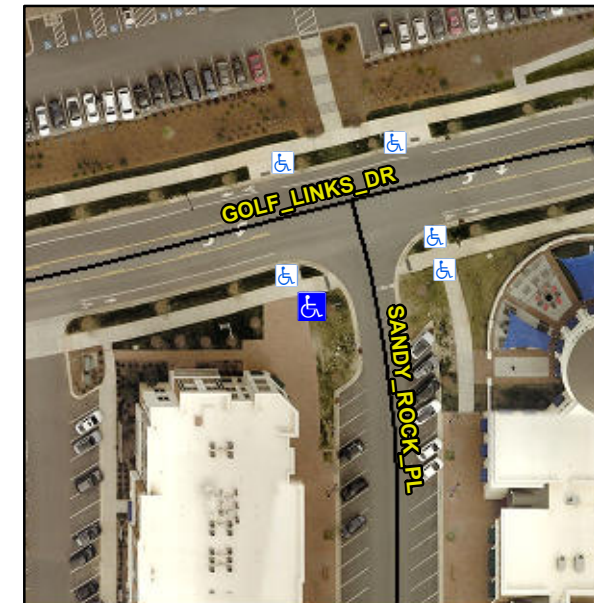
Compliance	Description	Data	Compliance	Description	Data
N/A	Ramp Length (in)	100.0	N/A	Grade Break?	N/A
Yes	Ramp Width (in)	84.0	N/A	Grade Break Slope (%)	0.0
Yes	Ramp Slope (%)	5.7	N/A	Grade Break XSlope (%)	0.0
No	Ramp XSlope (%)	3.1			
N/A	Flare Type LT	N/A	N/A	Flare Type RT	N/A
N/A	Flare Slope LT (%)	N/A	N/A	Flare Slope RT (%)	0.0
N/A	Flare Traversable LT?	N/A	N/A	Flare Traversable RT?	N/A
N/A	Landing Length (in)	0.0	N/A	DWS Provided?	N/A
N/A	Landing Width (in)	0.0	N/A	DWS Contrast?	N/A
N/A	Landing Slope (%)	0.0	N/A	DWS Length (in)	N/A
N/A	Landing X Slope (%)	0.0	N/A	DWS Full Width?	N/A
N/A	Landing Curb? (Y/N)	N/A	N/A	DWS Offset LT (in)	N/A
N/A	Shared Landing?	N/A	N/A	DWS Offset RT (in)	N/A
N/A	Gutter Ponding?	0.0	N/A	Gutter Slope (%)	N/A
N/A	Gutter Lip Ht (in)	0.0	N/A	Gutter X Slope (%)	N/A
N/A	Painted X Walk1?	No		Road Slope (%)	1.1
	X Walk 1 Direction	To E		Road X Slope (%)	2.9
	X Walk 1 Width (in)	N/A		Clear Space?	N/A

X Walk 1 Slope (%)	1.1	N/A	Clear Space to XWalk (in)	N/A
	X Walk 1 X Slope (%)	2.9	N/A	Storm Grate/Utility Hazard?	N/A
N/A	Ramp inside XWalk1?	N/A		Storm Grate/Utility Type	
N/A	Any Obstructions?	N/A			N/A
	Obstruction Type		Yes	Surface Condition? (G/P)	Good
			N/A	Curb Slope (%)	9.4

Possible Solutions:

Remove & Replace Entire Ramp.

R304.5.3
