# Access Compliance Report

## Public Rights-of-Way

### (Curb Ramps)

| Intersection ID: 29275 | Main Street: CHALK_HILL_LN | Cross Street: PAWLEY_DR | Location: NW |

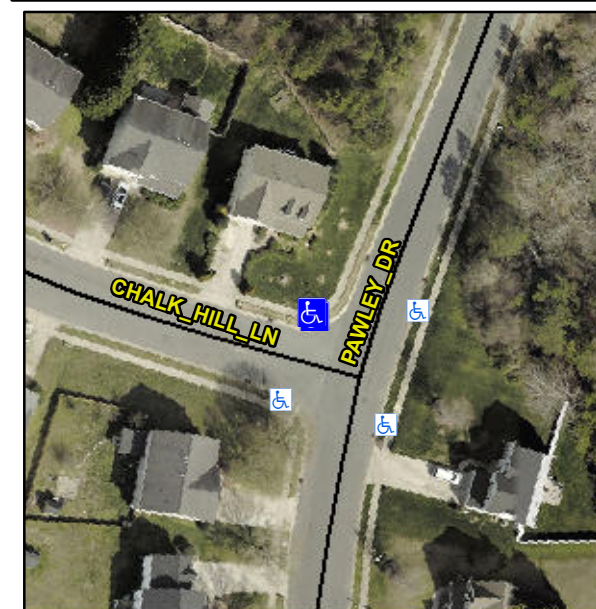
| ADA ID: 147822A5479F | Ramp Type: PerpDiag | Initial Pass/Fail: Fail | Overall Compliance: No |
| Severity Score: 33.75 | | | |

**Not Found, R304.5.1, R304.5.3**

| Compliance | Description | Data | Compliance | Description | Data |
|---|---|---|---|---|---|
| N/A | Ramp Length (in) | 48.0 | Yes | Ramp Slope (%) | 5.2 |
| No | Ramp Width (in) | 47.0 | No | Ramp XSlope (%) | 9.0 |

**Remove & Replace Curb Ramp With Two New Directional Ramps or Equivalent.**

Total Cost: \$ 3200.00
