Access Compliance Report

Public Rights-of-Way

(Curb Ramps)

Intersection ID: 5749	Main Street: NEVIN_RD	Cross Street: WHITE_PINE_LN	Location: NW
ADA ID: 1478DE1F78EE	Ramp Type: Perp	Initial Pass/Fail: Fail	Overall Compliance: No
Severity Score: 22.5			
Codes/Mitigation Info/Possible Solution		Field Measurements/Component Compliance

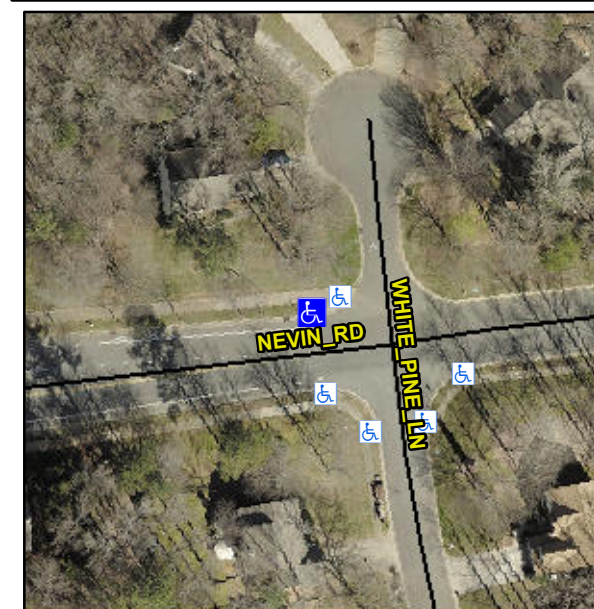
Not Found, R304.5.1, R304.2.2

Compliance	Description	Data	Compliance	Description	Data
N/A	Ramp Length (in)	72.0	No	Ramp Slope (%)	10.7
No	Ramp Width (in)	47.0	Yes	Ramp XSlope (%)	3.4
N/A	Flare Type LT	N/A	N/A	Flare Type RT	N/A
N/A	Flare Slope LT (%)	N/A	N/A	Flare Slope RT (%)	N/A
N/A	Flare Traversable LT?	N/A	N/A	Flare Traversable RT?	N/A
N/A	Landing Length (in)	N/A	N/A	DWS Provided?	N/A
N/A	Landing Width (in)	N/A	N/A	DWS Contrast?	N/A
N/A	Landing Slope (%)	N/A	N/A	DWS Length (in)	N/A
N/A	Landing X Slope (%)	N/A	N/A	DWS Full Width?	N/A
N/A	Landing Curb? (Y/N)	N/A	N/A	DWS Offset (in)	N/A
N/A	Shared Landing?	N/A			
N/A	Gutter Ponding?	N/A	N/A	Gutter Slope (%)	N/A
N/A	Gutter Lip Ht (in)	N/A	N/A	Gutter X Slope (%)	N/A
N/A	Painted X Walk1?	No	N/A	Painted X Walk2?	N/A
	X Walk 1 Direction	To S		X Walk 2 Direction	N/A
N/A	X Walk 1 Width (in)	N/A	N/A	X Walk 2 Width (in)	N/A
	X Walk 1 Slope (%)	4.3		X Walk 2 Slope (%)	N/A
	X Walk 1 X Slope (%)	4.5		X Walk 2 X Slope (%)	N/A

N/A	Ramp inside XWalk1?	N/A	N/A	Ramp inside XWalk2?	N/A
	Road Slope (%)	N/A	N/A	Clear Space?	N/A
	Road X Slope (%)	N/A	N/A	Clear Space to XWalk (in)	N/A
N/A	Any Obstructions?	N/A	N/A	Storm Grate/Utility Hazard?	N/A
	Obstruction Type			Storm Grate/Utility Type	
		N/A			N/A
		Yes		Surface Condition? (G/P)	Good

Remove & Replace Entire Ramp.
