# Access Compliance Report

## Public Rights-of-Way

| Intersection ID: 12012 | Main Street: PARSON_ST | Cross Street: KENNON_ST | Location: | N |
| ADA ID: 1492E7E2521B | Ramp Type: PerpDiag | Initial Pass/Fail: Fail | Overall Compliance: No | Severity Score: 30 |

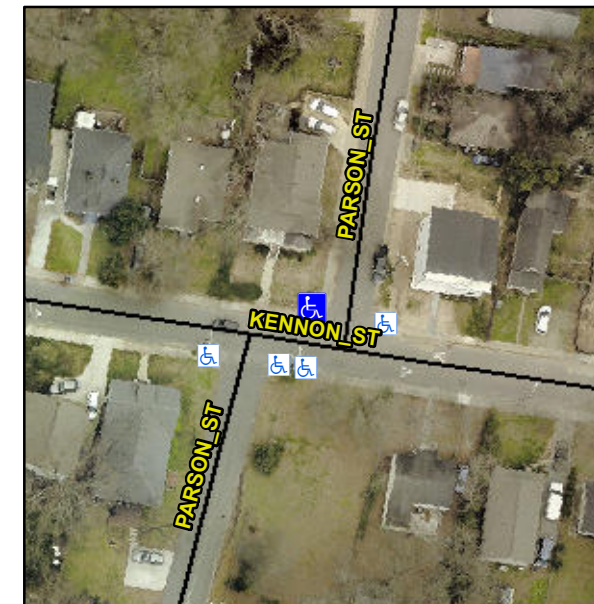
**Not Found, R304.5.1, R304.2.2**

| Compliance | Description | Data | Compliance | Description | Data |
|---|---|---|---|---|---|
| N/A | Ramp Length (in) | 58.0 | No | Ramp Slope (%) | 10.2 |
| No | Ramp Width (in) | 32.0 | Yes | Ramp XSlope (%) | 1.8 |

**Remove & Replace Curb Ramp With Two New Directional Ramps or Equivalent.**
