# Access Compliance Report

## Public Rights-of-Way

### (Curb Ramps)

Intersection ID: 42923	Main Street: BRAY_DR	Cross Street: LIFFORD_DR	Location: W
ADA ID: 14A65B8532A4	Ramp Type: PerpDiag	Initial Pass/Fail: Fail	Overall Compliance: No
Severity Score: 42.5			
Codes/Mitigation Info/Possible Solution		Field Measurements/Component Compliance

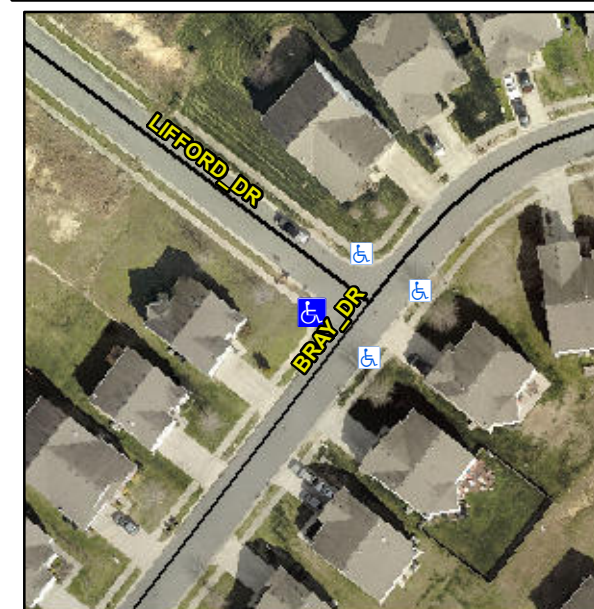
**Not Found, R304.5.1, R304.2.2, R304.5.3**

Compliance	Description	Data	Compliance	Description	Data
N/A	Ramp Length (in)	48.0	No	Ramp Slope (%)	8.4
No	Ramp Width (in)	34.0	No	Ramp XSlope (%)	6.3
N/A	Flare Type LT	N/A	N/A	Flare Type RT	N/A
N/A	Flare Slope LT (%)	N/A	N/A	Flare Slope RT (%)	N/A
N/A	Flare Traversable LT?	N/A	N/A	Flare Traversable RT?	N/A
N/A	Landing Length (in)	N/A	N/A	DWS Provided?	N/A
N/A	Landing Width (in)	N/A	N/A	DWS Contrast?	N/A
N/A	Landing Slope (%)	N/A	N/A	DWS Length (in)	N/A
N/A	Landing X Slope (%)	N/A	N/A	DWS Full Width?	N/A
N/A	Landing Curb? (Y/N)	N/A	N/A	DWS Offset (in)	N/A
N/A	Shared Landing?	N/A			
N/A	Gutter Ponding?	N/A	N/A	Gutter Slope (%)	N/A
N/A	Gutter Lip Ht (in)	N/A	N/A	Gutter X Slope (%)	N/A
N/A	Painted X Walk1?	No	N/A	Painted X Walk2?	No
	X Walk 1 Direction	To SE		X Walk 2 Direction	To NE
N/A	X Walk 1 Width (in)	N/A	N/A	X Walk 2 Width (in)	N/A
	X Walk 1 Slope (%)	5.4		X Walk 2 Slope (%)	0.5
	X Walk 1 X Slope (%)	3.8		X Walk 2 X Slope (%)	4.6

N/A	Ramp inside XWalk1?	N/A	N/A	Ramp inside XWalk2?	N/A
	Road Slope (%)	5.9	N/A	Clear Space?	N/A
	Road X Slope (%)	2.1	N/A	Clear Space to XWalk (in)	N/A
N/A	Any Obstructions?	N/A	N/A	Storm Grate/Utility Hazard?	N/A
	Obstruction Type			Storm Grate/Utility Type	
		N/A			N/A
			Yes	Surface Condition? (G/P)	Good

Possible Solutions:

**Remove & Replace Curb Ramp With Two New Directional Ramps or Equivalent.**
