Access Compliance Report Public Rights-of-Way (Curb Ramps)

Intersection ID: 50592 Main Street: BENDING_BRANCH_RD Cross Street: BRISTLEY_RD Location: SW

ADA ID: 14B94E855711 Ramp Type: Perp Initial Pass/Fail: Fail Overall Compliance: No Severity Score: 12.5

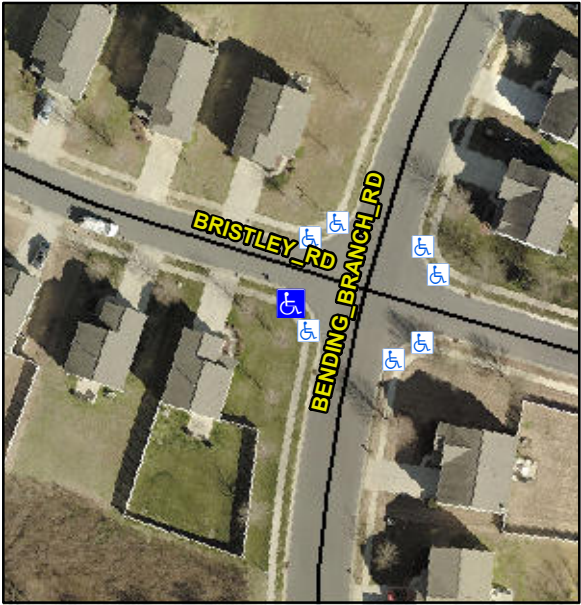
PROW/ADA:
Not Found, R304.5.3

Compliance	Description	Data	Compliance	Description	Data
N/A	Ramp Length (in)	48.5	Yes	Ramp Slope (%)	7.7
Yes	Ramp Width (in)	48.0	No	Ramp XSlope (%)	5.6
N/A	Flare Type LT	N/A	N/A	Flare Type RT	N/A
N/A	Flare Slope LT (%)	N/A	N/A	Flare Slope RT (%)	N/A
N/A	Flare Traversable LT?	N/A	N/A	Flare Traversable RT?	N/A
N/A	Landing Length (in)	N/A	N/A	DWS Provided?	N/A
N/A	Landing Width (in)	N/A	N/A	DWS Contrast?	N/A
N/A	Landing Slope (%)	N/A	N/A	DWS Length (in)	N/A
N/A	Landing X Slope (%)	N/A	N/A	DWS Full Width?	N/A
N/A	Landing Curb? (Y/N)	N/A	N/A	DWS Offset (in)	N/A
N/A	Shared Landing?	N/A			
N/A	Gutter Ponding?	N/A	N/A	Gutter Slope (%)	N/A
N/A	Gutter Lip Ht (in)	N/A	N/A	Gutter X Slope (%)	N/A
N/A	Painted X Walk1?	No	N/A	Painted X Walk2?	N/A
	X Walk 1 Direction	To N		X Walk 2 Direction	N/A
N/A	X Walk 1 Width (in)	N/A	N/A	X Walk 2 Width (in)	N/A
	X Walk 1 Slope (%)	1.4		X Walk 2 Slope (%)	N/A
	X Walk 1 X Slope (%)	4.0		X Walk 2 X Slope (%)	N/A

N/A	Ramp inside XWalk1?	N/A	N/A	Ramp inside XWalk2?	N/A
	Road Slope (%)	N/A	N/A	Clear Space?	N/A
	Road X Slope (%)	N/A	N/A	Clear Space to XWalk (in)	N/A
N/A	Any Obstructions?	N/A	N/A	Storm Grate/Utility Hazard?	N/A
	Obstruction Type			Storm Grate/Utility Type	
			N/A		N/A
			Yes	Surface Condition? (G/P)	Good

Possible Solutions:
Remove & Replace Entire Ramp.

Total Cost: \$ **1850.00**
