Access Compliance Report

Public Rights-of-Way

(Curb Ramps)

Intersection ID: 5822	Main Street: GUM_BRANCH_RD	Cross Street: MELLWOOD_DR	Location: E
ADA ID: 14BF3811B02D	Ramp Type: Directional1	Initial Pass/Fail: Fail	Overall Compliance: No
		Severity Score: 12.5

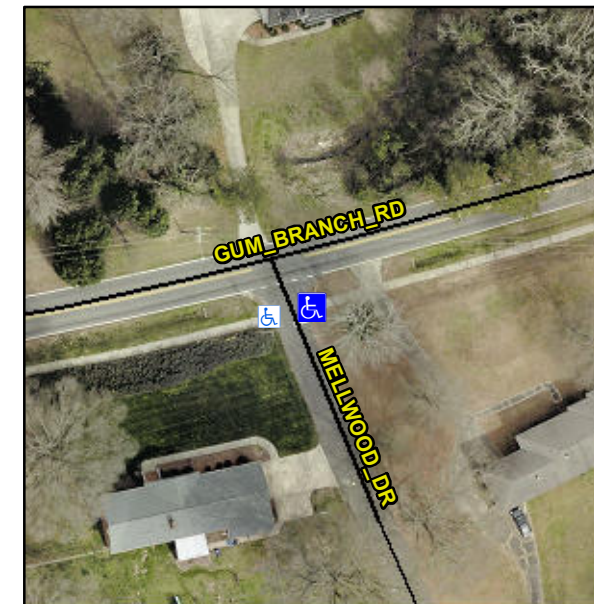
Compliance	Description	Data	Compliance	Description	Data
N/A	Ramp Length (in)	54.0	N/A	Grade Break?	N/A
Yes	Ramp Width (in)	60.0	N/A	Grade Break Slope (%)	0.0
Yes	Ramp Slope (%)	6.7	N/A	Grade Break XSlope (%)	0.0
No	Ramp XSlope (%)	6.0			
N/A	Flare Type LT	N/A	N/A	Flare Type RT	N/A
N/A	Flare Slope LT (%)	N/A	N/A	Flare Slope RT (%)	0.0
N/A	Flare Traversable LT?	N/A	N/A	Flare Traversable RT?	N/A
N/A	Landing Length (in)	0.0	N/A	DWS Provided?	N/A
N/A	Landing Width (in)	0.0	N/A	DWS Contrast?	N/A
N/A	Landing Slope (%)	0.0	N/A	DWS Length (in)	N/A
N/A	Landing X Slope (%)	0.0	N/A	DWS Full Width?	N/A
N/A	Landing Curb? (Y/N)	N/A	N/A	DWS Offset LT (in)	N/A
N/A	Shared Landing?	N/A	N/A	DWS Offset RT (in)	N/A
N/A	Gutter Ponding?	0.0	N/A	Gutter Slope (%)	N/A
N/A	Gutter Lip Ht (in)	0.0	N/A	Gutter X Slope (%)	N/A
N/A	Painted X Walk1?	No		Road Slope (%)	1.6
	X Walk 1 Direction	To W		Road X Slope (%)	5.3
	X Walk 1 Width (in)	N/A		Clear Space?	N/A

X Walk 1 Slope (%)	1.6	N/A	Clear Space to XWalk (in)	N/A
	X Walk 1 X Slope (%)	5.3	N/A	Storm Grate/Utility Hazard?	N/A
N/A	Ramp inside XWalk1?	N/A		Storm Grate/Utility Type	
N/A	Any Obstructions?	N/A			N/A
	Obstruction Type		Yes	Surface Condition? (G/P)	Good
			N/A	Curb Slope (%)	2.3

Remove & Replace Entire Ramp.

R304.5.3

\$ 1600.00
