Access Compliance Report

Public Rights-of-Way

(Curb Ramps)

| Intersection ID: 19999 | Main Street: SARDIS_RD | Cross Street: LANSLOWNE_RD | Location: SW |

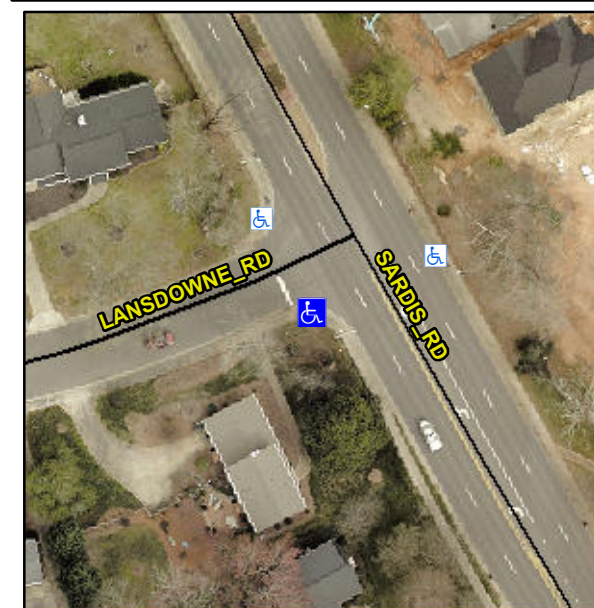
| ADA ID: 14CB5A456EA5 | Ramp Type: PerpDiag | Initial Pass/Fail: Fail | Overall Compliance: No |
| Severity Score: 35 | | | |

Not Found, R304.5.1, R304.2.2, R304.5.3

| Compliance | Description | Data | Compliance | Description | Data |
|---|---|---|---|---|---|
| N/A | Ramp Length (in) | 61.0 | No | Ramp Slope (%) | 12.8 |
| No | Ramp Width (in) | 39.0 | No | Ramp XSlope (%) | 4.1 |

Remove & Replace Curb Ramp With Two New Directional Ramps or Equivalent.

Total Cost: \$ 3200.00
