Access Compliance Report Public Rights-of-Way (Curb Ramps)

Intersection ID: 17896 Main Street: BELROSE_LN Cross Street: SCALEYBARK_RD Location: SE

ADA ID: 14CDFFA939CC Ramp Type: BlendTrans1 Initial Pass/Fail: Fail Overall Compliance: No Severity Score: 1.25

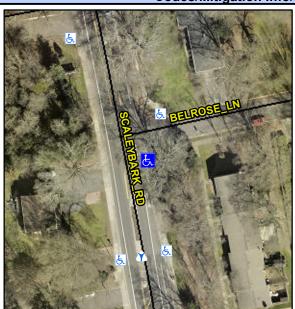
CURB SLIGHTLY MODIFIED

Not Found, R304.5.3

Field Measurements/Component Compliance					
Compliance Description		Data	Comp	liance Description	Data
N/A	Ramp Length (in)	163.0	Yes	BlendTrans Slope (%)	1.2
Yes	Ramp Width (in)	59.0	No	BlendTrans XSlope (%)	2.9
N/A	Flare Type LT	N/A	N/A	Flare Type RT	N/A
N/A	Flare Slope LT (%)	N/A	N/A	Flare Slope RT (%)	N/A
N/A	Flare Traversable LT?	N/A	N/A	Flare Traversable RT?	N/A
N/A	Landing Length (in)	N/A	N/A	DWS Provided?	N/A
N/A	Landing Width (in)	N/A	N/A	DWS Contrast?	N/A
N/A	Landing Slope (%)	N/A	N/A	DWS Length (in)	N/A
N/A	Landing X Slope (%)	N/A	N/A	DWS Full Width?	N/A
N/A	Landing Curb? (Y/N)	N/A	N/A	DWS Offset (in)	N/A
N/A	Shared Landing?	N/A			
N/A	Gutter Ponding?	N/A	N/A	Gutter Slope (%)	N/A
N/A	Gutter Lip Ht (in)	N/A	N/A	Gutter X Slope (%)	N/A
N/A	Painted X Walk1?	No	N/A	Painted X Walk2?	N/A
	X Walk 1 Direction	To N		X Walk 2 Direction	N/A
	X Walk 1 Width (in)	N/A		X Walk 2 Width (in)	N/A
	X Walk 1 Slope (%)	3.1		X Walk 2 Slope (%)	N/A

X Walk 1 X Slope (%)	3.0		X Walk 2 X Slope (%)	N/A
N/A	Ramp inside XWalk1?	N/A	N/A	Ramp inside XWalk2?	N/A
	Road Slope (%)	3.0		Clear Space?	N/A
	Road X Slope (%)	3.1	N/A	Clear Space to XWalk (in)	N/A
N/A	Any Obstructions?	N/A	N/A	Storm Grate/Utility Hazard?	N/A
	Obstruction Type			Storm Grate/Utility Type	
		N/A			N/A
			Yes	Surface Condition? (G/P)	Good
			No	Curb Slope (%)	16.2
	NAME OF TAXABLE PARTY.

Remove & Replace Curb Ramp With Two New Directional Ramps or Equivalent.

Total Cost: \$ 3200.00
