Intersection ID: 52582	Main Street: NOBLES_AV	Cross Street: N/A	Location:	N
ADA ID: 14E187CDC2A9	Ramp Type: Perp	Initial Pass/Fail: Fail	Overall Compliance: No	Severity Score: 13.75

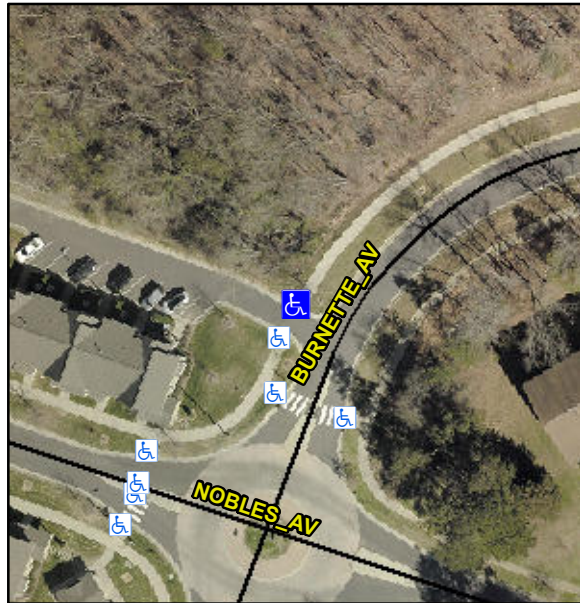
**Not Found, R304.2.2, R304.5.3**

Compliance	Description	Data	Compliance	Description	Data
N/A	Ramp Length (in)	74.0	No	Ramp Slope (%)	8.4
Yes	Ramp Width (in)	70.0	No	Ramp XSlope (%)	3.1
N/A	Flare Type LT	N/A	N/A	Flare Type RT	N/A
N/A	Flare Slope LT (%)	N/A	N/A	Flare Slope RT (%)	N/A
N/A	Flare Traversable LT?	N/A	N/A	Flare Traversable RT?	N/A
N/A	Landing Length (in)	N/A	N/A	DWS Provided?	N/A
N/A	Landing Width (in)	N/A	N/A	DWS Contrast?	N/A
N/A	Landing Slope (%)	N/A	N/A	DWS Length (in)	N/A
N/A	Landing X Slope (%)	N/A	N/A	DWS Full Width?	N/A
N/A	Landing Curb? (Y/N)	N/A	N/A	DWS Offset (in)	N/A
N/A	Shared Landing?	N/A			
N/A	Gutter Ponding?	N/A	N/A	Gutter Slope (%)	N/A
N/A	Gutter Lip Ht (in)	N/A	N/A	Gutter X Slope (%)	N/A
N/A	Painted X Walk1?	No	N/A	Painted X Walk2?	N/A
	X Walk 1 Direction	To SW		X Walk 2 Direction	N/A
N/A	X Walk 1 Width (in)	N/A	N/A	X Walk 2 Width (in)	N/A
	X Walk 1 Slope (%)	2.1		X Walk 2 Slope (%)	N/A
	X Walk 1 X Slope (%)	2.3		X Walk 2 X Slope (%)	N/A

N/A	Ramp inside XWalk1?	N/A	N/A	Ramp inside XWalk2?	N/A
	Road Slope (%)	N/A	N/A	Clear Space?	N/A
	Road X Slope (%)	N/A	N/A	Clear Space to XWalk (in)	N/A
N/A	Any Obstructions?	N/A	N/A	Storm Grate/Utility Hazard?	N/A
	Obstruction Type			Storm Grate/Utility Type	
		N/A			N/A
			Yes	Surface Condition? (G/P)	Good

### Remove & Replace Entire Ramp.

Total Cost: \$ 1850.00
