# Access Compliance Report

## Public Rights-of-Way

### (Curb Ramps)

Intersection ID: N/A	Main Street: INDEPENDENCE_BV	Cross Street: N/A	Location: SW
ADA ID: 14E79C4B9AED	Ramp Type: Perp	Initial Pass/Fail: Fail	Overall Compliance: No
Severity Score: 13.75			
Codes/Mitigation Info/Possible Solution		Field Measurements/Component Compliance

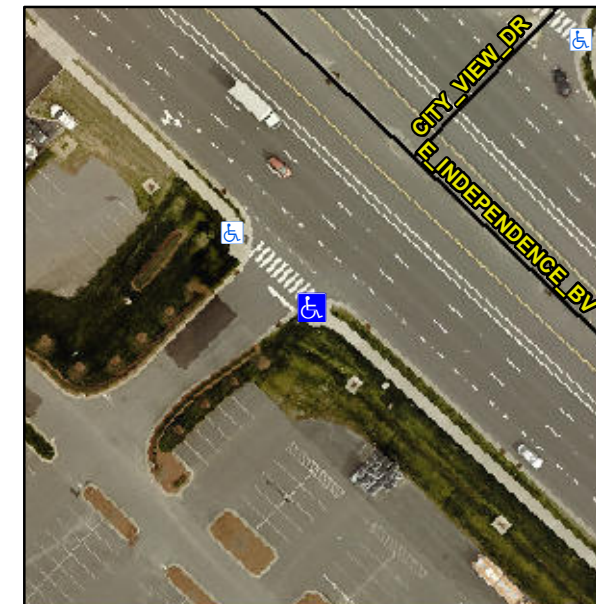
Compliance	Description	Data	Compliance	Description	Data
N/A	Ramp Length (in)	71.5	No	Ramp Slope (%)	9.6
Yes	Ramp Width (in)	59.5	No	Ramp XSlope (%)	4.3
N/A	Flare Type LT	N/A	N/A	Flare Type RT	N/A
N/A	Flare Slope LT (%)	N/A	N/A	Flare Slope RT (%)	N/A
N/A	Flare Traversable LT?	N/A	N/A	Flare Traversable RT?	N/A
N/A	Landing Length (in)	N/A	N/A	DWS Provided?	N/A
N/A	Landing Width (in)	N/A	N/A	DWS Contrast?	N/A
N/A	Landing Slope (%)	N/A	N/A	DWS Length (in)	N/A
N/A	Landing X Slope (%)	N/A	N/A	DWS Full Width?	N/A
N/A	Landing Curb? (Y/N)	N/A	N/A	DWS Offset (in)	N/A
N/A	Shared Landing?	N/A			
N/A	Gutter Ponding?	N/A	N/A	Gutter Slope (%)	N/A
N/A	Gutter Lip Ht (in)	N/A	N/A	Gutter X Slope (%)	N/A
N/A	Painted X Walk1?	Yes	N/A	Painted X Walk2?	N/A
	X Walk 1 Direction	To NW		X Walk 2 Direction	N/A
N/A	X Walk 1 Width (in)	120.5	N/A	X Walk 2 Width (in)	N/A
	X Walk 1 Slope (%)	0.1		X Walk 2 Slope (%)	N/A
	X Walk 1 X Slope (%)	7.2		X Walk 2 X Slope (%)	N/A

N/A	Ramp inside XWalk1?	Yes	N/A	Ramp inside XWalk2?	N/A
	Road Slope (%)	N/A	N/A	Clear Space?	N/A
	Road X Slope (%)	N/A	N/A	Clear Space to XWalk (in)	N/A
N/A	Any Obstructions?	N/A	N/A	Storm Grate/Utility Hazard?	N/A
	Obstruction Type			Storm Grate/Utility Type	
		N/A			N/A
		Yes		Surface Condition? (G/P)	Good

Possible Solutions:

**Remove & Replace Entire Ramp.**

**Not Found, R304.2.2, R304.5.3**
