Access Compliance Report

Public Rights-of-Way

(Curb Ramps)

Intersection ID: 16611	Main Street: BEVERLY_DR	Cross Street: RENSFORD_AV	Location: W
ADA ID: 14E9BFB6A831	Ramp Type: PerpDiag	Initial Pass/Fail: Fail	Overall Compliance: No
Severity Score: 13.75			
Codes/Mitigation Info/Possible Solution		Field Measurements/Component Compliance

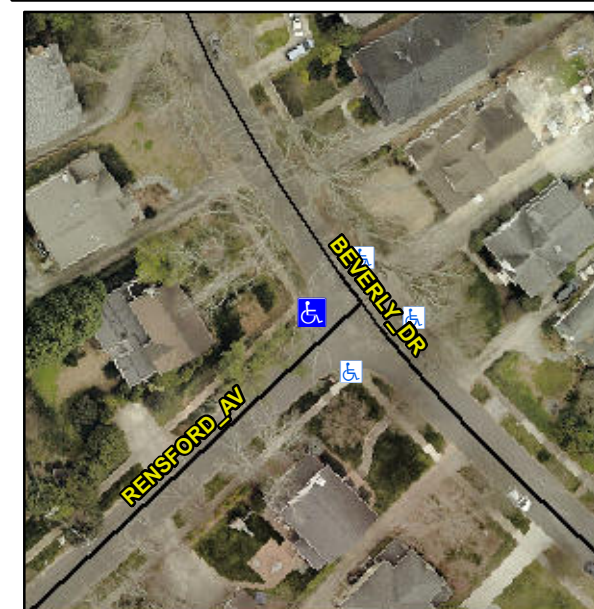
R304.2.2, R304.5.3

Compliance	Description	Data	Compliance	Description	Data
N/A	Ramp Length (in)	48.0	No	Ramp Slope (%)	10.9
Yes	Ramp Width (in)	79.0	No	Ramp XSlope (%)	2.2
N/A	Flare Type LT	N/A	N/A	Flare Type RT	N/A
N/A	Flare Slope LT (%)	N/A	N/A	Flare Slope RT (%)	N/A
N/A	Flare Traversable LT?	N/A	N/A	Flare Traversable RT?	N/A
N/A	Landing Length (in)	N/A	N/A	DWS Provided?	N/A
N/A	Landing Width (in)	N/A	N/A	DWS Contrast?	N/A
N/A	Landing Slope (%)	N/A	N/A	DWS Length (in)	N/A
N/A	Landing X Slope (%)	N/A	N/A	DWS Full Width?	N/A
N/A	Landing Curb? (Y/N)	N/A	N/A	DWS Offset (in)	N/A
N/A	Shared Landing?	N/A			
N/A	Gutter Ponding?	N/A	N/A	Gutter Slope (%)	N/A
N/A	Gutter Lip Ht (in)	N/A	N/A	Gutter X Slope (%)	N/A
N/A	Painted X Walk1?	No	N/A	Painted X Walk2?	No
	X Walk 1 Direction	To SE		X Walk 2 Direction	To NE
N/A	X Walk 1 Width (in)	N/A	N/A	X Walk 2 Width (in)	N/A
	X Walk 1 Slope (%)	0.8		X Walk 2 Slope (%)	0.8
	X Walk 1 X Slope (%)	3.6		X Walk 2 X Slope (%)	1.7

N/A	Ramp inside XWalk1?	N/A	N/A	Ramp inside XWalk2?	N/A
	Road Slope (%)	3.4	N/A	Clear Space?	N/A
	Road X Slope (%)	3.4	N/A	Clear Space to XWalk (in)	N/A
N/A	Any Obstructions?	N/A	N/A	Storm Grate/Utility Hazard?	N/A
	Obstruction Type			Storm Grate/Utility Type	
		N/A			N/A
		Yes		Surface Condition? (G/P)	Good

Possible Solutions:

Remove & Replace Curb Ramp With Two New Directional Ramps or Equivalent.
