Access Compliance Report

Public Rights-of-Way

(Curb Ramps)

Intersection ID: 11640	Main Street: E_W_T_HARRIS_BV	Cross Street: WILLIAMS_RD	Location: SW
ADA ID: 14EE1647BE51	Ramp Type: PerpDiag	Initial Pass/Fail: Fail	Overall Compliance: No
Codes/Mitigation Info/Possible Solution		Field Measurements/Component Compliance	
Severity Score: 12.5

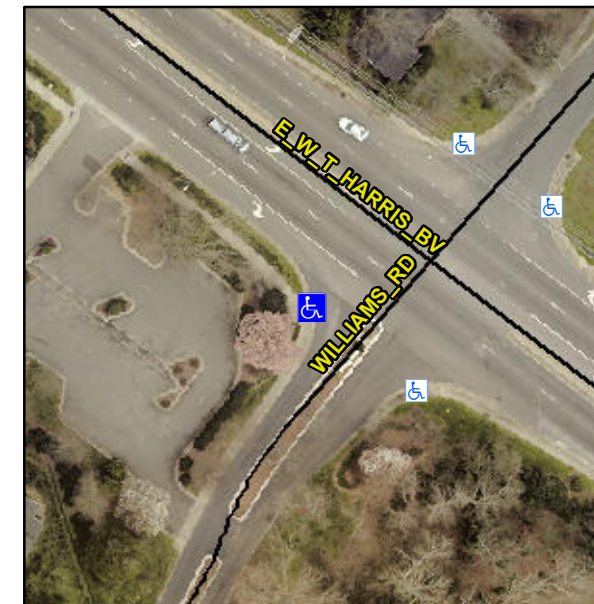
Compliance	Description	Data	Compliance	Description	Data
N/A	Ramp Length (in)	60.0	No	Ramp Slope (%)	9.4
Yes	Ramp Width (in)	48.0	Yes	Ramp XSlope (%)	1.6
N/A	Flare Type LT	N/A	N/A	Flare Type RT	N/A
N/A	Flare Slope LT (%)	N/A	N/A	Flare Slope RT (%)	N/A
N/A	Flare Traversable LT?	N/A	N/A	Flare Traversable RT?	N/A
N/A	Landing Length (in)	N/A	N/A	DWS Provided?	N/A
N/A	Landing Width (in)	N/A	N/A	DWS Contrast?	N/A
N/A	Landing Slope (%)	N/A	N/A	DWS Length (in)	N/A
N/A	Landing X Slope (%)	N/A	N/A	DWS Full Width?	N/A
N/A	Landing Curb? (Y/N)	N/A	N/A	DWS Offset (in)	N/A
N/A	Shared Landing?	N/A			
N/A	Gutter Ponding?	N/A	N/A	Gutter Slope (%)	N/A
N/A	Gutter Lip Ht (in)	N/A	N/A	Gutter X Slope (%)	N/A
N/A	Painted X Walk1?	No	N/A	Painted X Walk2?	No
	X Walk 1 Direction	To E		X Walk 2 Direction	To N
N/A	X Walk 1 Width (in)	N/A	N/A	X Walk 2 Width (in)	N/A
	X Walk 1 Slope (%)	1.5		X Walk 2 Slope (%)	3.1
	X Walk 1 X Slope (%)	2.1		X Walk 2 X Slope (%)	0.5

N/A	Ramp inside XWalk1?	N/A	N/A	Ramp inside XWalk2?	N/A
	Road Slope (%)	1.8	N/A	Clear Space?	N/A
	Road X Slope (%)	0.9	N/A	Clear Space to XWalk (in)	N/A
N/A	Any Obstructions?	N/A	N/A	Storm Grate/Utility Hazard?	N/A
	Obstruction Type			Storm Grate/Utility Type	
		N/A			N/A
			Yes	Surface Condition? (G/P)	Good

Possible Solutions:

Remove & Replace Curb Ramp With Two New Directional Ramps or Equivalent.

Not Found, R304.2.2
