Access Compliance Report

Public Rights-of-Way

(Curb Ramps)

Intersection ID: 31292	Main Street: DEERTON_RD	Cross Street: MUNSING_DR	Location: NW
ADA ID: 14F6326B4295	Ramp Type: PerpDiag	Initial Pass/Fail: Fail	Overall Compliance: No
			Severity Score: 21.25

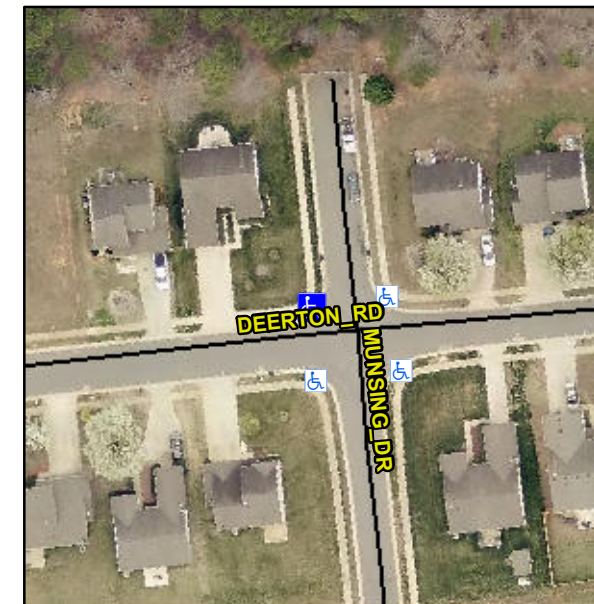
Compliance	Description	Data	Compliance	Description	Data
N/A	Ramp Length (in)	50.0	No	Ramp Slope (%)	8.8
No	Ramp Width (in)	37.0	Yes	Ramp XSlope (%)	1.8
N/A	Flare Type LT	N/A	N/A	Flare Type RT	N/A
N/A	Flare Slope LT (%)	N/A	N/A	Flare Slope RT (%)	N/A
N/A	Flare Traversable LT?	N/A	N/A	Flare Traversable RT?	N/A
N/A	Landing Length (in)	N/A	N/A	DWS Provided?	N/A
N/A	Landing Width (in)	N/A	N/A	DWS Contrast?	N/A
N/A	Landing Slope (%)	N/A	N/A	DWS Length (in)	N/A
N/A	Landing X Slope (%)	N/A	N/A	DWS Full Width?	N/A
N/A	Landing Curb? (Y/N)	N/A	N/A	DWS Offset (in)	N/A
N/A	Shared Landing?	N/A			
N/A	Gutter Ponding?	N/A	N/A	Gutter Slope (%)	N/A
N/A	Gutter Lip Ht (in)	N/A	N/A	Gutter X Slope (%)	N/A
N/A	Painted X Walk1?	No	N/A	Painted X Walk2?	No
	X Walk 1 Direction	To E		X Walk 2 Direction	To S
N/A	X Walk 1 Width (in)	N/A	N/A	X Walk 2 Width (in)	N/A
	X Walk 1 Slope (%)	2.3		X Walk 2 Slope (%)	1.8
	X Walk 1 X Slope (%)	2.9		X Walk 2 X Slope (%)	0.7

N/A	Ramp inside XWalk1?	N/A	N/A	Ramp inside XWalk2?	N/A
	Road Slope (%)	3.3	N/A	Clear Space?	N/A
	Road X Slope (%)	0.7	N/A	Clear Space to XWalk (in)	N/A
N/A	Any Obstructions?	N/A	N/A	Storm Grate/Utility Hazard?	N/A
	Obstruction Type			Storm Grate/Utility Type	
		N/A			N/A
			Yes	Surface Condition? (G/P)	Good

Possible Solutions:

Remove & Replace Curb Ramp With Two New Directional Ramps or Equivalent.

R304.5.1, R304.2.2
