# Access Compliance Report

## Public Rights-of-Way

### (Curb Ramps)

Intersection ID: N/A	Main Street: E_STONEWALL_ST	Cross Street: S_CALDWELL_ST	Location: S
ADA ID: 150796609A76	Ramp Type: BlendTrans1	Initial Pass/Fail: Pass	Overall Compliance: No
Severity Score: 0.25			
Codes/Mitigation Info/Possible Solution		Field Measurements/Component Compliance

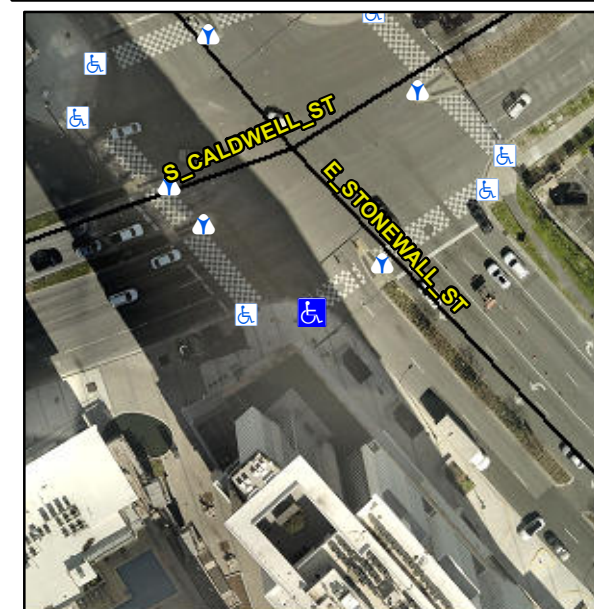
Compliance	Description	Data	Compliance	Description	Data
N/A	Ramp Length (in)	73.0	Yes	BlendTrans Slope (%)	2.3
Yes	Ramp Width (in)	71.0	No	BlendTrans XSlope (%)	4.3
N/A	Flare Type LT	Sloped	N/A	Flare Type RT	Sloped
N/A	Flare Slope LT (%)	5.5	N/A	Flare Slope RT (%)	8.7
N/A	Flare Traversable LT?	No	N/A	Flare Traversable RT?	No
Yes	Landing Length (in)	60.0	Yes	DWS Provided?	Yes
Yes	Landing Width (in)	60.0	Yes	DWS Contrast?	Yes
Yes	Landing Slope (%)	1.7	Yes	DWS Length (in)	24.0
Yes	Landing X Slope (%)	2.0	Yes	DWS Full Width?	Yes
N/A	Landing Curb? (Y/N)	No	Yes	DWS Offset (in)	1.0
N/A	Shared Landing?	No			
Yes	Gutter Ponding?	No	Yes	Gutter Slope (%)	0.7
Yes	Gutter Lip Ht (in)	0.0	No	Gutter X Slope (%)	2.4
N/A	Painted X Walk1?	Yes	N/A	Painted X Walk2?	N/A
	X Walk 1 Direction	To NE		X Walk 2 Direction	N/A
	X Walk 1 Width (in)	144.0		X Walk 2 Width (in)	N/A
	X Walk 1 Slope (%)	0.5		X Walk 2 Slope (%)	N/A
	X Walk 1 X Slope (%)	1.6		X Walk 2 X Slope (%)	N/A

Yes	Ramp inside XWalk1?	Yes	N/A	Ramp inside XWalk2?	N/A
	Road Slope (%)	1.6		Clear Space?	Yes
	Road X Slope (%)	0.5	N/A	Clear Space to XWalk (in)	N/A
Yes	Any Obstructions?	No	Yes	Storm Grate/Utility Hazard?	No
	Obstruction Type			Storm Grate/Utility Type	
		N/A			N/A
			Yes	Surface Condition? (G/P)	Good
			No	Curb Slope (%)	12.6

**Remove & Replace Curb Ramp With Two New Directional Ramps or Equivalent. Remove & Replace Gutter.**

**Not Found, R304.5.3**
