Access Compliance Report Public Rights-of-Way (Curb Ramps)

Intersection ID: 27451 Main Street: PROVIDENCE_RD Cross Street: ALLISON_WOODS_DR Location: SE

ADA ID: 15093931C6EF Ramp Type: Perp Initial Pass/Fail: Fail Overall Compliance: No Severity Score: 22.5

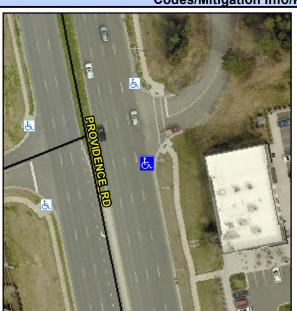
Comp	liance Description	Data	Comp	liance Description	Data
N/A	Ramp Length (in)	71.0	No	Ramp Slope (%)	8.5
No	Ramp Width (in)	46.5	Yes	Ramp XSlope (%)	2.4
N/A	Flare Type LT	N/A	N/A	Flare Type RT	N/A
N/A	Flare Slope LT (%)	N/A	N/A	Flare Slope RT (%)	N/A
N/A	Flare Traversable LT?	N/A	N/A	Flare Traversable RT?	N/A
N/A	Landing Length (in)	N/A	N/A	DWS Provided?	N/A
N/A	Landing Width (in)	N/A	N/A	DWS Contrast?	N/A
N/A	Landing Slope (%)	N/A	N/A	DWS Length (in)	N/A
N/A	Landing X Slope (%)	N/A	N/A	DWS Full Width?	N/A
N/A	Landing Curb? (Y/N)	N/A	N/A	DWS Offset (in)	N/A
N/A	Shared Landing?	N/A			
N/A	Gutter Ponding?	N/A	N/A	Gutter Slope (%)	N/A
N/A	Gutter Lip Ht (in)	N/A	N/A	Gutter X Slope (%)	N/A
N/A	Painted X Walk1?	Yes	N/A	Painted X Walk2?	N/A
	X Walk 1 Direction	To N		X Walk 2 Direction	N/A
N/A	X Walk 1 Width (in)	75.0	N/A	X Walk 2 Width (in)	N/A
	X Walk 1 Slope (%)	0.7		X Walk 2 Slope (%)	N/A
	X Walk 1 X Slope (%)	2.5		X Walk 2 X Slope (%)	N/A

N/A	Ramp inside XWalk1?	Yes	N/A	Ramp inside XWalk2?	N/A
	Road Slope (%)	N/A	N/A	Clear Space?	N/A
	Road X Slope (%)	N/A	N/A	Clear Space to XWalk (in)	N/A
N/A	Any Obstructions?	N/A	N/A	Storm Grate/Utility Hazard?	N/A
	Obstruction Type			Storm Grate/Utility Type	
		N/A			N/A
			Yes	Surface Condition? (G/P)	Good

Possible Solutions:	9	
Remove & Replace Entire Ramp.		
	1	
	1	
	ı	
	ı	
	ı	
Surveyor Notes:	ı	
N/A	ı	
	ı	
	ı	
	ı	
PROW/ADA:	ı	
Not Found, R304.5.1, R304.2.2	ı	
	ı	
	ı
