Access Compliance Report

Public Rights-of-Way

(Curb Ramps)

Intersection ID: 19457	Main Street: S_TRYON_ST	Cross Street: YORKDALE_DR	Location: SE
ADA ID: 150A2E392043	Ramp Type: PerpDiag	Initial Pass/Fail: Fail	Overall Compliance: No
			Severity Score: 13.75

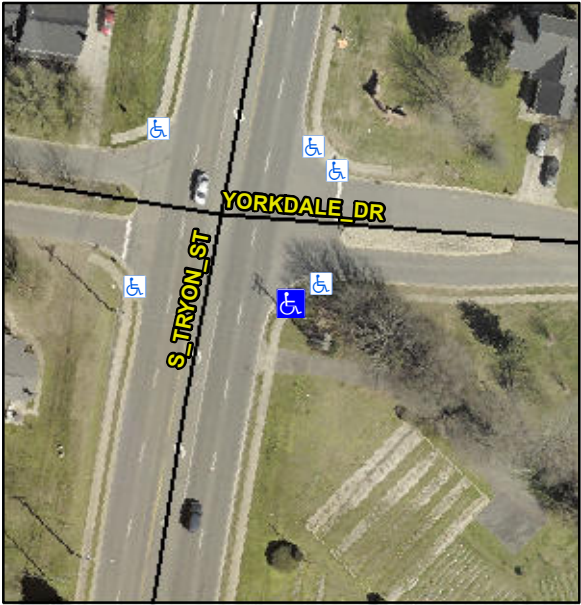
Possible Solutions:		Compliance	Description	Data
	Remove & Replace Curb Ramp With Two New Directional Ramps or Equivalent.		N/A	Ramp Length (in)	80.0
			Yes	Ramp Width (in)	48.0
			N/A	Flare Type LT	N/A
			N/A	Flare Slope LT (%)	N/A
			N/A	Flare Traversable LT?	N/A
			N/A	Landing Length (in)	N/A
			N/A	Landing Width (in)	N/A
			N/A	Landing Slope (%)	N/A
			N/A	Landing X Slope (%)	N/A
<p>Surveyor Notes:</p> <p>N/A</p> <p>PROW/ADA:</p> <p>R304.2.2, R304.5.3</p>			N/A	Flare Type RT	N/A
			N/A	Flare Slope RT (%)	N/A
			N/A	Flare Traversable RT?	N/A
			N/A	DWS Provided?	N/A
			N/A	DWS Contrast?	N/A
			N/A	DWS Length (in)	N/A
			N/A	DWS Full Width?	N/A
			N/A	DWS Offset (in)	N/A
			N/A	Gutter Ponding?	N/A
			N/A	Gutter Lip Ht (in)	N/A
<p>Total Cost:</p> <p>\$ 3200.00</p>			N/A	Painted X Walk1?	No
			N/A	X Walk 1 Direction	To N
			N/A	X Walk 1 Width (in)	N/A

N/A	X Walk 1 Slope (%)	3.1
			N/A	X Walk 1 X Slope (%)	6.0
			N/A	Ramp inside XWalk1?	N/A
			N/A	Road Slope (%)	1.9
			N/A	Road X Slope (%)	5.2
			N/A	Any Obstructions?	N/A
			N/A	Obstruction Type	
			N/A	Clear Space?	N/A
			N/A	Clear Space to XWalk (in)	N/A
			N/A	Storm Grate/Utility Hazard?	N/A
			N/A	Storm Grate/Utility Type	
			N/A		N/A
			Yes	Surface Condition? (G/P)	Good
