# Access Compliance Report

## Public Rights-of-Way

### (Curb Ramps)

| Intersection ID: 49789 | Main Street: BARLEY_LN | Cross Street: GRASS_DR | Location: | N |

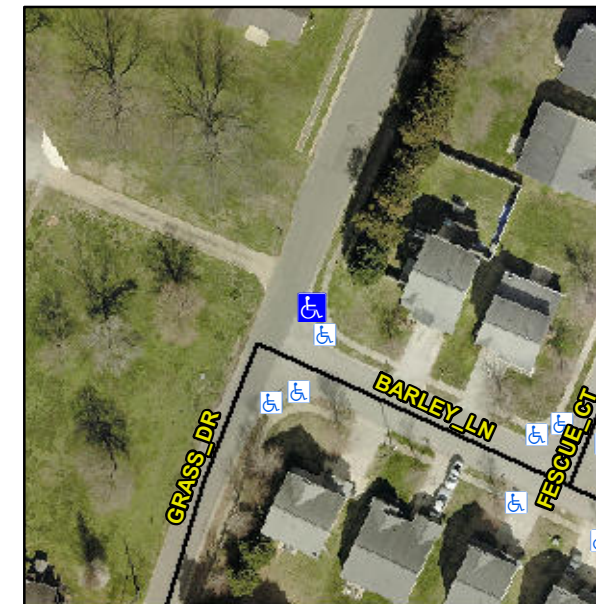
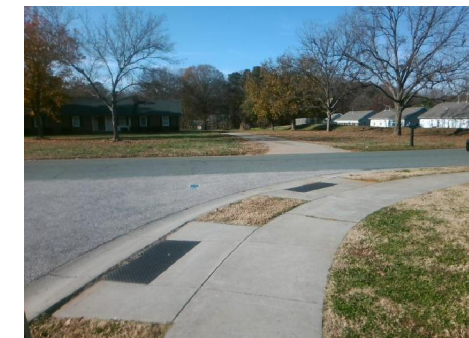
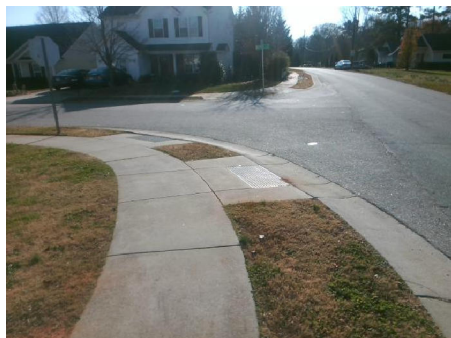
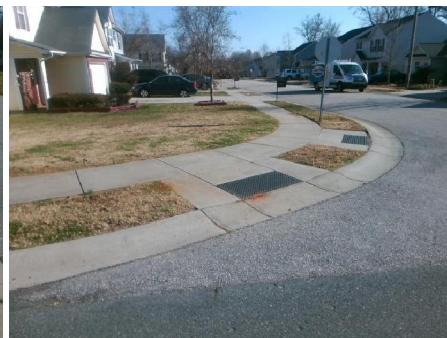
| ADA ID: 150CC58BF0D4 | Ramp Type: Perp | Initial Pass/Fail: Pass | Overall Compliance: No | Severity Score: 5.25 |

**Not Found, R304.5.3, R304.2.2-Perp,  
R304.3.2-Para, R304.5.4**

| Compliance | Description | Data | Compliance | Description | Data |
|---|---|---|---|---|---|
| Yes | Ramp Width (in) | 48.5 | No | Ramp XSlope (%) | 2.5 |
| No | Landing Slope (%) | 3.2 | Yes | DWS Length (in) | 24.5 |
| No | Landing X Slope (%) | 3.4 | Yes | DWS Full Width? | Yes |
| Yes | Gutter Ponding? | No | No | Gutter Slope (%) | 7.7 |
| Yes | Gutter Lip Ht (in) | 0.0 | No | Gutter X Slope (%) | 2.3 |

Possible Solutions:

**Remove & Replace Entire Ramp.  
Remove & Replace Gutter.**

Total Cost: \$ 2600.00
