Access Compliance Report Public Rights-of-Way (Curb Ramps)

Intersection ID: 51481	Main St	reet: KRISTENS_MARE_DR	Cross	Street:	ARDWYCK_P	L		Location:	N	
ADA ID: 15127F3F661D	Ramp T	Ramp Type: PerpDiag			ail: Pass (ce: N	o Severity Score:	0		
Codes/Mitigation Info/Possible Solution					Field Measurements/Component Compliance					
		Possible Solutions:		Compliance Description			Data Compliance Description			
		Remove & Replace Curb Ramp W	Vith	N/A	Ramp Length (in)) 48.0	Yes	Ramp Slope (%)	7.4	
1 China and		Two New Directional Ramps or		Yes	Ramp Width (in)	48.0	Yes	Ramp XSlope (%)	0.4	
		Equivalent.		N/A	Flare Type LT	Sloped	N/A	Flare Type RT	N/A	
				N/A	Flare Slope LT (%	%) 5.4	Yes	Flare Slope RT (%)	4.4	
	11/15			N/A	Flare Traversable	,	N/A	Flare Traversable RT?	Yes	
	No 12			No	Landing Length (i		Yes	DWS Provided?	Yes

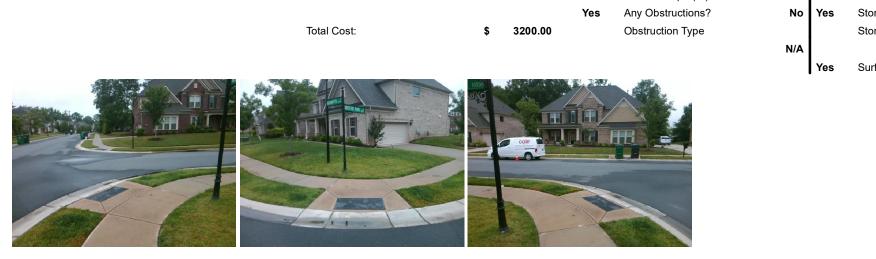
S. OM	Surveyor Notes:		Yes	Landing Width (in	ו) 48.0	Yes	DWS Contrast?	Yes	
E Contraction of the second se		N/A		Yes	Landing Slope (%	6) 1.3	Yes	DWS Length (in)	24.0	
				Yes	Landing X Slope		Yes	DWS Full Width?	Yes

6.34				N/A	Landing Curb? (Y		No	DWS Offset (in)	4.0	
5 1 1 1 1 1 1 1 1 1 1 1 1 1 1 1 1 1 1 1		2		N/A	Shared Landing?	,				
		PROW/ADA:		Yes	Gutter Ponding?		Yes	Gutter Slope (%)	2.6	
	1	Not Found, R304.2.1, R305.2		Yes	Gutter Lip Ht (in)		Yes	Gutter X Slope (%)	1.6	
	NY TENT C.			N/A	Painted X Walk1		N/A	Painted X Walk2?	No	
3 1/ / Jan 4	XXXXX				X Walk 1 Directio	on To SW		X Walk 2 Direction	To SE	
1112	All and the			N/A	X Walk 1 Width (i	in) N/A	N/A	X Walk 2 Width (in)	N/A	
Street 1 Name	ARDWYCK PL	-			X Walk 1 Slope (,		X Walk 2 Slope (%)	1.4	
Stop Condition-Street 2	StopSign				X Walk 1 X Slope	,		X Walk 2 X Slope (%)	1.4	
Street 2 Name	KRISTENS MARE DR			N/A	Ramp inside XWa	alk1? N/A	N/A	Ramp inside XWalk2?	N/A	
Stop Condition-Street 1	None				Road Slope (%)	0.4	N/A	Clear Space?	Yes	
					Road X Slope (%	b) 1.6	N/A	Clear Space to XWalk (in)	N/A	
				Yes	Any Obstructions		Yes	Storm Grate/Utility Hazard?	No

s Surface Condition? (G/P) Good

Total Cost: \$ 3	200.00		Obstruction Type			Storm Grate/Utility Type		
						N/A			N/A
