# Access Compliance Report

## Public Rights-of-Way

| Intersection ID: 44786 | Main Street: AYRSLEY_TOWN_BV | Cross Street: KINGS_PARADE_BV | Location: SE |
| ADA ID: 1514ABEA8350 | Ramp Type: Perp | Initial Pass/Fail: Fail | Overall Compliance: No |

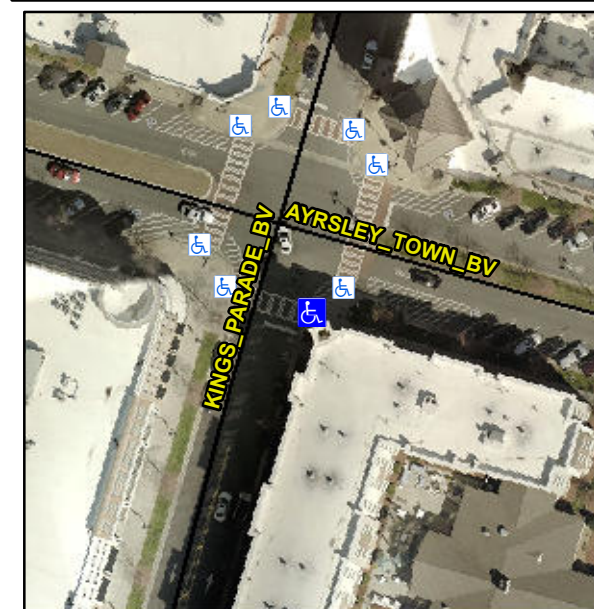
**Not Found, R304.2.2, R304.5.3**

| Compliance | Description | Data | Compliance | Description | Data |
|---|---|---|---|---|---|
| N/A | Ramp Length (in) | 91.0 | No | Ramp Slope (%) | 9.2 |
| Yes | Ramp Width (in) | 48.0 | No | Ramp XSlope (%) | 3.2 |

**Remove & Replace Entire Ramp.**

Total Cost: \$ 1850.00
