Access Compliance Report

Public Rights-of-Way

(Curb Ramps)

Intersection ID: 14652	Main Street: DRIFTWOOD_DR	Cross Street: MCMANUS_DR	Location: NE
ADA ID: 1517632600D1	Ramp Type: BlendTrans1	Initial Pass/Fail: Fail	Overall Compliance: No
		Severity Score: 12.5

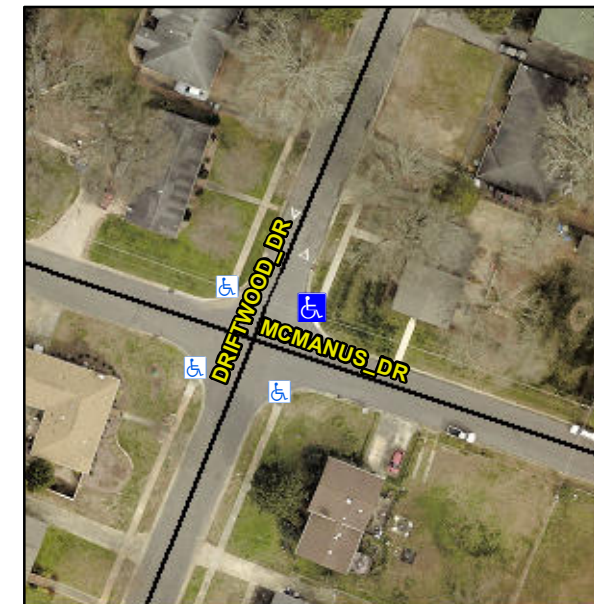
Not Found, R304.5.3

Compliance	Description	Data	Compliance	Description	Data
N/A	Ramp Length (in)	74.0	Yes	BlendTrans Slope (%)	4.6
Yes	Ramp Width (in)	56.0	No	BlendTrans XSlope (%)	5.3
N/A	Flare Type LT	N/A	N/A	Flare Type RT	N/A
N/A	Flare Slope LT (%)	N/A	N/A	Flare Slope RT (%)	N/A
N/A	Flare Traversable LT?	N/A	N/A	Flare Traversable RT?	N/A
N/A	Landing Length (in)	N/A	N/A	DWS Provided?	N/A
N/A	Landing Width (in)	N/A	N/A	DWS Contrast?	N/A
N/A	Landing Slope (%)	N/A	N/A	DWS Length (in)	N/A
N/A	Landing X Slope (%)	N/A	N/A	DWS Full Width?	N/A
N/A	Landing Curb? (Y/N)	N/A	N/A	DWS Offset (in)	N/A
N/A	Shared Landing?	N/A			
N/A	Gutter Ponding?	N/A	N/A	Gutter Slope (%)	N/A
N/A	Gutter Lip Ht (in)	N/A	N/A	Gutter X Slope (%)	N/A
N/A	Painted X Walk1?	No	N/A	Painted X Walk2?	No
	X Walk 1 Direction	To W		X Walk 2 Direction	To S
	X Walk 1 Width (in)	N/A		X Walk 2 Width (in)	N/A
	X Walk 1 Slope (%)	4.3		X Walk 2 Slope (%)	N/A
	X Walk 1 X Slope (%)	0.3		X Walk 2 X Slope (%)	N/A

N/A	Ramp inside XWalk1?	N/A	N/A	Ramp inside XWalk2?	N/A
	Road Slope (%)	0.3		Clear Space?	N/A
	Road X Slope (%)	4.3	N/A	Clear Space to XWalk (in)	N/A
N/A	Any Obstructions?	N/A	N/A	Storm Grate/Utility Hazard?	N/A
	Obstruction Type			Storm Grate/Utility Type	
		N/A			N/A
			Yes	Surface Condition? (G/P)	Good
			No	Curb Slope (%)	11.3

Remove & Replace Curb Ramp With Two New Directional Ramps or Equivalent.
