Access Compliance Report

Public Rights-of-Way

(Curb Ramps)

Intersection ID: 43248	Main Street: LAMPLIGHTER_PL	Cross Street: STONEMAN_PL	Location: NW
ADA ID: 151CB394E4A7	Ramp Type: BlendTrans2	Initial Pass/Fail: Fail	Overall Compliance: No
Severity Score: 35			
Codes/Mitigation Info/Possible Solution		Field Measurements/Component Compliance

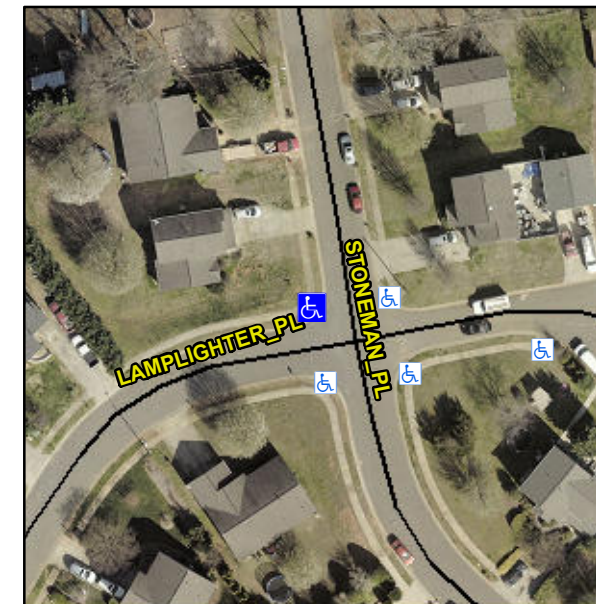
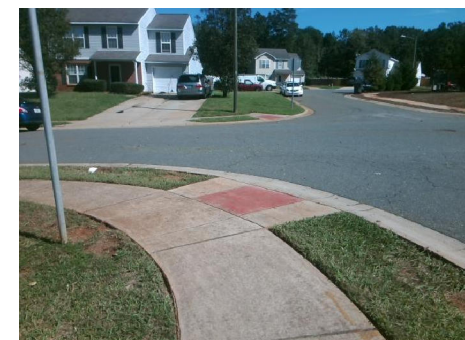
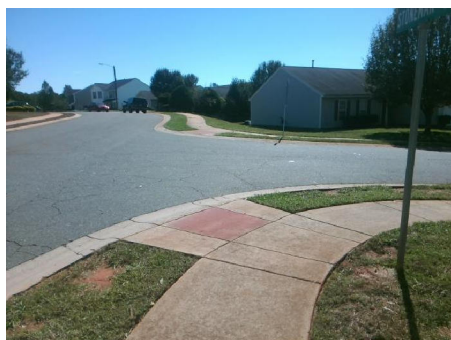
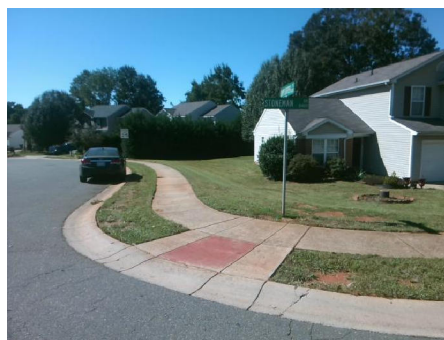
Compliance	Description	Data	Compliance	Description	Data
N/A	Ramp Length (in)	97.0	Yes	BlendTrans Slope (%)	2.4
No	Ramp Width (in)	28.0	Yes	BlendTrans XSlope (%)	1.3
N/A	Flare Type LT	N/A	N/A	Flare Type RT	N/A
N/A	Flare Slope LT (%)	N/A	N/A	Flare Slope RT (%)	N/A
N/A	Flare Traversable LT?	N/A	N/A	Flare Traversable RT?	N/A
N/A	Landing Length (in)	N/A	N/A	DWS Provided?	N/A
N/A	Landing Width (in)	N/A	N/A	DWS Contrast?	N/A
N/A	Landing Slope (%)	N/A	N/A	DWS Length (in)	N/A
N/A	Landing X Slope (%)	N/A	N/A	DWS Full Width?	N/A
N/A	Landing Curb? (Y/N)	N/A	N/A	DWS Offset (in)	N/A
N/A	Shared Landing?	N/A			
N/A	Gutter Ponding?	N/A	N/A	Gutter Slope (%)	N/A
N/A	Gutter Lip Ht (in)	N/A	N/A	Gutter X Slope (%)	N/A
N/A	Painted X Walk1?	No	N/A	Painted X Walk2?	No
	X Walk 1 Direction	To S		X Walk 2 Direction	To E
	X Walk 1 Width (in)	N/A		X Walk 2 Width (in)	N/A
	X Walk 1 Slope (%)	4.7		X Walk 2 Slope (%)	4.1
	X Walk 1 X Slope (%)	3.5		X Walk 2 X Slope (%)	5.6

N/A	Ramp inside XWalk1?	N/A	N/A	Ramp inside XWalk2?	N/A
	Road Slope (%)	0.9		Clear Space?	N/A
	Road X Slope (%)	6.7	N/A	Clear Space to XWalk (in)	N/A
N/A	Any Obstructions?	N/A	N/A	Storm Grate/Utility Hazard?	N/A
	Obstruction Type			Storm Grate/Utility Type	
		N/A			N/A
		Yes		Surface Condition? (G/P)	Good
		No		Curb Slope (%)	10.3

Possible Solutions:

Remove & Replace Curb Ramp With Two New Directional Ramps or Equivalent.
