# Access Compliance Report

## Public Rights-of-Way

### (Curb Ramps)

Intersection ID: 10024262	Main Street: CRAIG_AV	Cross Street: N/A	Location: SE
ADA ID: 1523DC75EAF8	Ramp Type: PerpDiag	Initial Pass/Fail: Fail	Overall Compliance: No
		Severity Score: 37.5

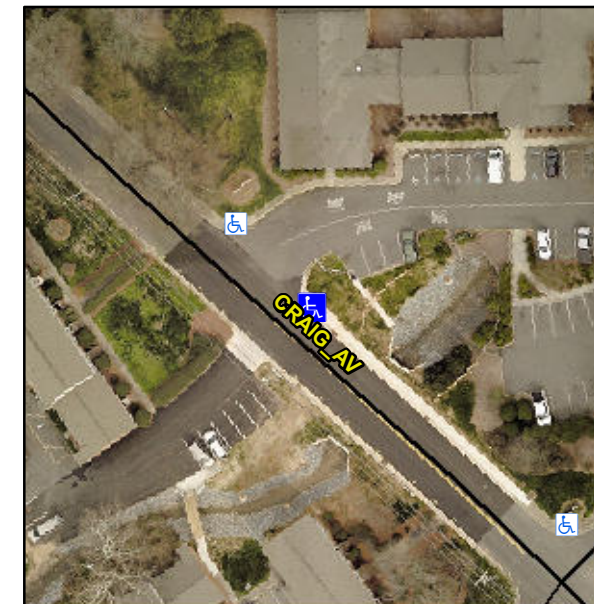
**Not Found, R304.2.2, R304.5.3**

Compliance	Description	Data	Compliance	Description	Data
N/A	Ramp Length (in)	48.0	No	Ramp Slope (%)	13.9
Yes	Ramp Width (in)	48.0	No	Ramp XSlope (%)	6.6
N/A	Flare Type LT	N/A	N/A	Flare Type RT	N/A
N/A	Flare Slope LT (%)	N/A	N/A	Flare Slope RT (%)	N/A
N/A	Flare Traversable LT?	N/A	N/A	Flare Traversable RT?	N/A
N/A	Landing Length (in)	N/A	N/A	DWS Provided?	N/A
N/A	Landing Width (in)	N/A	N/A	DWS Contrast?	N/A
N/A	Landing Slope (%)	N/A	N/A	DWS Length (in)	N/A
N/A	Landing X Slope (%)	N/A	N/A	DWS Full Width?	N/A
N/A	Landing Curb? (Y/N)	N/A	N/A	DWS Offset (in)	N/A
N/A	Shared Landing?	N/A			
N/A	Gutter Ponding?	N/A	N/A	Gutter Slope (%)	N/A
N/A	Gutter Lip Ht (in)	N/A	N/A	Gutter X Slope (%)	N/A
N/A	Painted X Walk1?	No	N/A	Painted X Walk2?	No
	X Walk 1 Direction	To SW		X Walk 2 Direction	To NW
N/A	X Walk 1 Width (in)	N/A	N/A	X Walk 2 Width (in)	N/A
	X Walk 1 Slope (%)	3.5		X Walk 2 Slope (%)	4.9
	X Walk 1 X Slope (%)	8.1		X Walk 2 X Slope (%)	4.5

N/A	Ramp inside XWalk1?	N/A	N/A	Ramp inside XWalk2?	N/A
	Road Slope (%)	6.2	N/A	Clear Space?	N/A
	Road X Slope (%)	5.5	N/A	Clear Space to XWalk (in)	N/A
N/A	Any Obstructions?	N/A	N/A	Storm Grate/Utility Hazard?	N/A
	Obstruction Type			Storm Grate/Utility Type	
		N/A			N/A
			Yes	Surface Condition? (G/P)	Good

**Remove & Replace Curb Ramp With Two New Directional Ramps or Equivalent.**

Total Cost: \$ 3200.00
