Access Compliance Report

Public Rights-of-Way

(Curb Ramps)

Intersection ID: 20177	Main Street: FAIRVIEW_RD	Cross Street: OGLUKIAN_RD	Location: SE
ADA ID: 1528DFCC9B91	Ramp Type: Perp	Initial Pass/Fail: Fail	Overall Compliance: No
Severity Score: 17.5			
Codes/Mitigation Info/Possible Solution		Field Measurements/Component Compliance

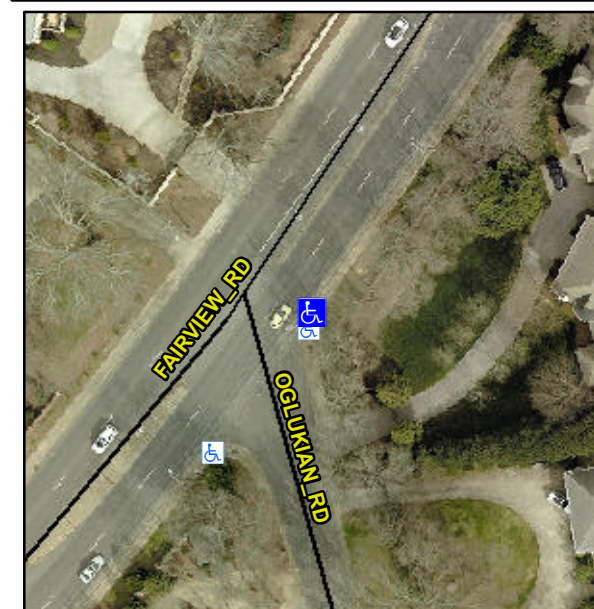
Not Found, R304.5.1

Compliance	Description	Data	Compliance	Description	Data
N/A	Ramp Length (in)	59.0	Yes	Ramp Slope (%)	7.2
No	Ramp Width (in)	35.0	Yes	Ramp XSlope (%)	0.9
N/A	Flare Type LT	N/A	N/A	Flare Type RT	N/A
N/A	Flare Slope LT (%)	N/A	N/A	Flare Slope RT (%)	N/A
N/A	Flare Traversable LT?	N/A	N/A	Flare Traversable RT?	N/A
N/A	Landing Length (in)	N/A	N/A	DWS Provided?	N/A
N/A	Landing Width (in)	N/A	N/A	DWS Contrast?	N/A
N/A	Landing Slope (%)	N/A	N/A	DWS Length (in)	N/A
N/A	Landing X Slope (%)	N/A	N/A	DWS Full Width?	N/A
N/A	Landing Curb? (Y/N)	N/A	N/A	DWS Offset (in)	N/A
N/A	Shared Landing?	N/A			
N/A	Gutter Ponding?	N/A	N/A	Gutter Slope (%)	N/A
N/A	Gutter Lip Ht (in)	N/A	N/A	Gutter X Slope (%)	N/A
N/A	Painted X Walk1?	No	N/A	Painted X Walk2?	N/A
	X Walk 1 Direction	To NW		X Walk 2 Direction	N/A
N/A	X Walk 1 Width (in)	N/A	N/A	X Walk 2 Width (in)	N/A
	X Walk 1 Slope (%)	0.0		X Walk 2 Slope (%)	N/A
	X Walk 1 X Slope (%)	1.0		X Walk 2 X Slope (%)	N/A

N/A	Ramp inside XWalk1?	N/A	N/A	Ramp inside XWalk2?	N/A
	Road Slope (%)	N/A	N/A	Clear Space?	N/A
	Road X Slope (%)	N/A	N/A	Clear Space to XWalk (in)	N/A
N/A	Any Obstructions?	N/A	N/A	Storm Grate/Utility Hazard?	N/A
	Obstruction Type			Storm Grate/Utility Type	
		N/A			N/A
			Yes	Surface Condition? (G/P)	Good

Possible Solutions:

Remove & Replace Entire Ramp.
