Access Compliance Report Public Rights-of-Way (Curb Ramps)

•		-					
Intersection ID: 2725	Main Street: SKYLINE_DR			Street:	SKYLINE_DR	Location:	SW		
ADA ID: 152D09BD71BE	Ramp Type: PerpDiag			Initial Pass/Fail: Fail Overall Compliance: No				o Severity Score:	46.25
Codes/Mitigation Info/Possible Solution				Field Measurements/Component Compliance					
		Possible Solutions:		Compliance Description			Data Compliance Description		Data
		Remove & Replace Curb Ramp	With	N/A	Ramp Length (in)	48.0	No	Ramp Slope (%)	13.7
		Two New Directional Ramps or		No	Ramp Width (in)	36.0	No	Ramp XSlope (%)	6.3
		Equivalent.		N/A	Flare Type LT	N/A	N/A	Flare Type RT	N/A
				N/A	Flare Slope LT (%)	N/A	N/A	Flare Slope RT (%)	N/A
				N/A	Flare Traversable LT?	N/A	N/A	Flare Traversable RT?	N/A
SKYLINE DR C				N/A	Landing Length (in)	N/A	N/A	DWS Provided?	N/A
		Surveyor Notes:		N/A	Landing Width (in)	N/A	N/A	DWS Contrast?	N/A
La contra c		N/A		N/A	Landing Slope (%)	N/A	N/A	DWS Length (in)	N/A

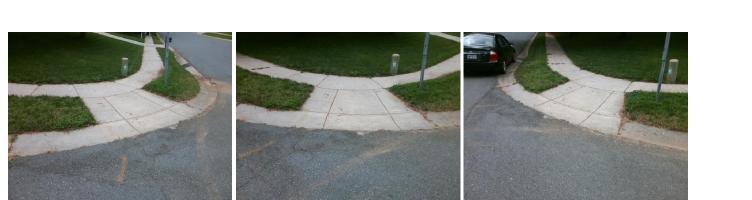
N/A	Landing X Slope (%)	N/A	N/A	DWS Full Width?	N/A
o l				N/A	Landing Curb? (Y/N)	N/A	N/A	DWS Offset (in)	N/A
The N				N/A	Shared Landing?	N/A		()	
		PROW/ADA:		N/A	Gutter Ponding?	N/A	N/A	Gutter Slope (%)	N/A
		Not Found, R304.5.1, R304.2.2,		N/A	Gutter Lip Ht (in)	N/A	N/A	Gutter X Slope (%)	N/A
And Marshare & Call		R304.5.3	<i>∠.</i> ∠,	N/A	Painted X Walk1?	No	N/A	Painted X Walk2?	No
	Har Mind				X Walk 1 Direction	To E		X Walk 2 Direction	To N
				N/A	X Walk 1 Width (in)	N/A	N/A	X Walk 2 Width (in)	N/A
Street 1 Name	SKYLINE DR	•			X Walk 1 Slope (%)	1.0		X Walk 2 Slope (%)	7.6
Stop Condition-Street 2	None				X Walk 1 X Slope (%)	10.1		X Walk 2 X Slope (%)	2.1
Street 2 Name	SKYLINE DR			N/A	Ramp inside XWalk1?	N/A	N/A	Ramp inside XWalk2?	N/A
Stop Condition-Street 1	StopSign				Road Slope (%)	5.5	N/A	Clear Space?	N/A
					Road X Slope (%)	7.5	N/A	Clear Space to XWalk (in)	N/A
				N/A	Any Obstructions?	N/A	N/A	Storm Grate/Utility Hazard?	N/A

Total Cost: \$	3200.00		Obstruction Type			Storm Grate/Utility Type	
		·			<i>,</i> ,,,,,,,,,,,,,,,,,,,,,,,,,,,,,,,,,,,	N/A			N/A
