Access Compliance Report

Public Rights-of-Way

(Curb Ramps)

| Intersection ID: 14469 | Main Street: E_MOREHEAD_ST | Cross Street: KENILWORTH_AV | Location: E |

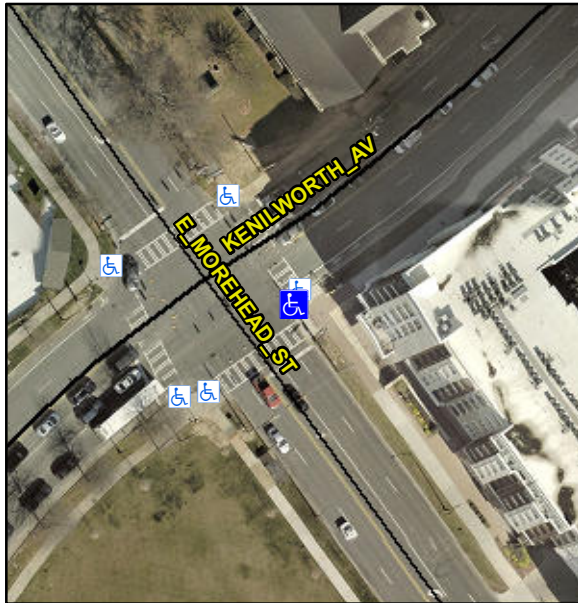
| ADA ID: 1535C2BB836B | Ramp Type: BlendTrans1 | Initial Pass/Fail: Pass | Overall Compliance: No |
| | | Severity Score: 0 | |

| Compliance | Description | Data | Compliance | Description | Data |
|---|---|---|---|---|---|
| N/A | Ramp Length (in) | 60.0 | Yes | BlendTrans Slope (%) | 3.1 |
| Yes | Ramp Width (in) | 60.0 | Yes | BlendTrans XSlope (%) | 0.9 |
| Yes | Flare Slope LT (%) | 4.9 | N/A | Flare Slope RT (%) | 6.2 |
| N/A | Flare Traversable LT? | Yes | N/A | Flare Traversable RT? | No |

Possible Solutions:

Remove & Replace Curb Slope and Extend Ramp.

Total Cost: \$ **2000.00**

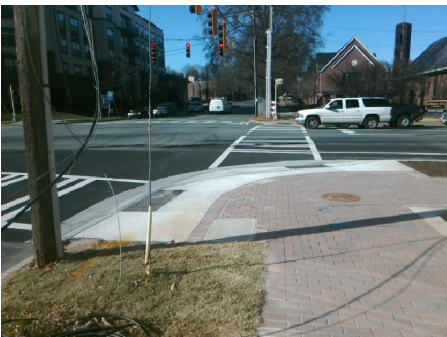
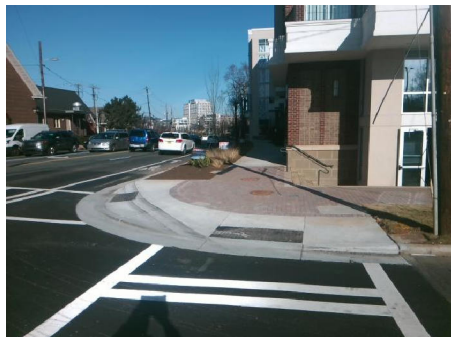
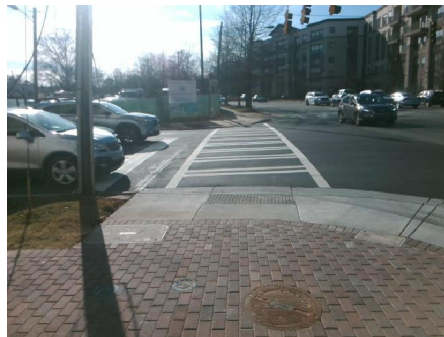
| Compliance | Description | Data | Compliance | Description | Data |
|---|---|---|---|---|---|
| | | | No | Curb Slope (%) | 14.0 |
