Access Compliance Report

Public Rights-of-Way

(Curb Ramps)

Intersection ID: 53096	Main Street: BRODIE_LN	Cross Street: DIXIE_RIVER_RD	Location: SE
ADA ID: 154C1BB528F6	Ramp Type: PerpDiag	Initial Pass/Fail: Fail	Overall Compliance: No
Severity Score: 8.75			
Codes/Mitigation Info/Possible Solution		Field Measurements/Component Compliance

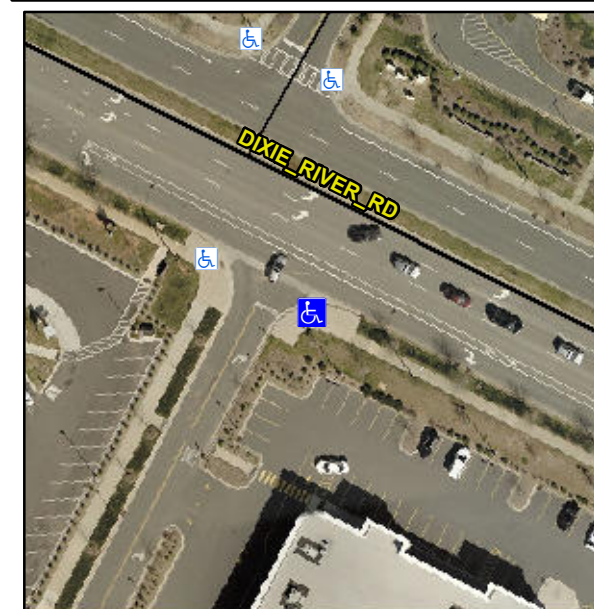
Compliance	Description	Data	Compliance	Description	Data
N/A	Ramp Length (in)	65.0	Yes	Ramp Slope (%)	6.9
No	Ramp Width (in)	47.0	Yes	Ramp XSlope (%)	1.2
N/A	Flare Type LT	N/A	N/A	Flare Type RT	N/A
N/A	Flare Slope LT (%)	N/A	N/A	Flare Slope RT (%)	N/A
N/A	Flare Traversable LT?	N/A	N/A	Flare Traversable RT?	N/A
N/A	Landing Length (in)	N/A	N/A	DWS Provided?	N/A
N/A	Landing Width (in)	N/A	N/A	DWS Contrast?	N/A
N/A	Landing Slope (%)	N/A	N/A	DWS Length (in)	N/A
N/A	Landing X Slope (%)	N/A	N/A	DWS Full Width?	N/A
N/A	Landing Curb? (Y/N)	N/A	N/A	DWS Offset (in)	N/A
N/A	Shared Landing?	N/A			
N/A	Gutter Ponding?	N/A	N/A	Gutter Slope (%)	N/A
N/A	Gutter Lip Ht (in)	N/A	N/A	Gutter X Slope (%)	N/A
N/A	Painted X Walk1?	No	N/A	Painted X Walk2?	No
	X Walk 1 Direction	To NE		X Walk 2 Direction	To NW
N/A	X Walk 1 Width (in)	N/A	N/A	X Walk 2 Width (in)	N/A
	X Walk 1 Slope (%)	5.7		X Walk 2 Slope (%)	2.7
	X Walk 1 X Slope (%)	0.6		X Walk 2 X Slope (%)	5.8

N/A	Ramp inside XWalk1?	N/A	N/A	Ramp inside XWalk2?	N/A
	Road Slope (%)	5.8	N/A	Clear Space?	N/A
	Road X Slope (%)	5.0	N/A	Clear Space to XWalk (in)	N/A
N/A	Any Obstructions?	N/A	N/A	Storm Grate/Utility Hazard?	N/A
	Obstruction Type			Storm Grate/Utility Type	
		N/A			N/A
			Yes	Surface Condition? (G/P)	Good

Possible Solutions:

Remove & Replace Curb Ramp With Two New Directional Ramps or Equivalent.
