# Access Compliance Report

## Public Rights-of-Way

| Intersection ID: 25832 | Main Street: STRAWBERRY_LN | Cross Street: FAIRWAY_DOWNS_CT | Location: SE |
| ADA ID: 154FB13DFC6F | Ramp Type: PerpDiag | Initial Pass/Fail: Fail | Overall Compliance: No |

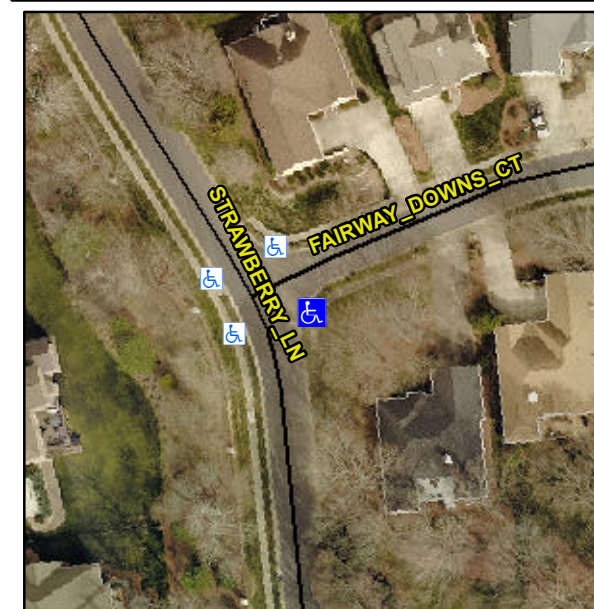
| Severity Score: 13.75 | | | |

**Not Found, R304.2.2, R304.5.3**

| Compliance | Description | Data | Compliance | Description | Data |
|---|---|---|---|---|---|
| N/A | Ramp Length (in) | 48.0 | No | Ramp Slope (%) | 9.5 |
| Yes | Ramp Width (in) | 48.0 | No | Ramp XSlope (%) | 2.8 |

**Remove & Replace Curb Ramp With Two New Directional Ramps or Equivalent.**

Total Cost: \$ 3200.00
