Intersection ID: 17139	Main Street: BRIABEND_DR	Cross Street: SOUTH_BV	Location:	SE
ADA ID: 1552ED1B6BAB	Ramp Type: ParaDiag	Initial Pass/Fail: Fail	Overall Compliance: No	Severity Score: 13.75

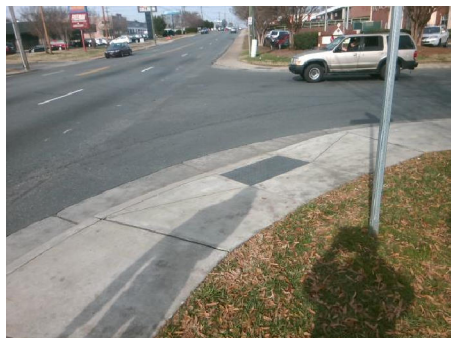
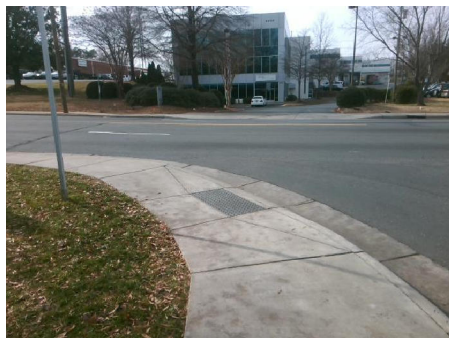
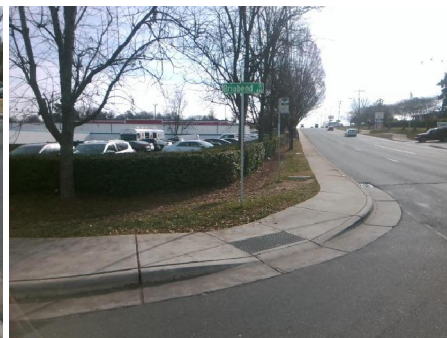
LT RP < 5%

Compliance	Description	Data	Compliance	Description	Data
N/A	Ramp Length LT (in)	49.0	N/A	Ramp Length RT (in)	52.0
Yes	Ramp Width LT (in)	60.0	Yes	Ramp Width RT (in)	59.0
Yes	Ramp Slope LT (%)	4.8	No	Ramp Slope RT (%)	11.4
Yes	Ramp XSlope LT (%)	1.3	No	Ramp XSlope RT (%)	4.0
N/A	Landing Length (in)	N/A	N/A	DWS Provided?	N/A
N/A	Landing Width (in)	N/A	N/A	DWS Contrast?	N/A
N/A	Landing Slope (%)	N/A	N/A	DWS Length (in)	N/A
N/A	Landing X Slope (%)	N/A	N/A	DWS Full Width?	N/A
N/A	Landing Curb? (Y/N)	N/A	N/A	DWS Offset (in)	N/A
N/A	Shared Landing?	N/A			
N/A	Gutter Ponding?	N/A	N/A	Gutter Slope (%)	N/A
N/A	Gutter Lip Ht (in)	N/A	N/A	Gutter X Slope (%)	N/A
N/A	Painted X Walk1?	No	N/A	Painted X Walk2?	No
	X Walk 1 Direction	To N		X Walk 2 Direction	To W
N/A	X Walk 1 Width (in)	N/A	N/A	X Walk 2 Width (in)	N/A
	X Walk 1 Slope (%)	1.5		X Walk 2 Slope (%)	3.4
	X Walk 1 X Slope (%)	3.7		X Walk 2 X Slope (%)	2.2
N/A	Ramp inside XWalk1?	N/A	N/A	Ramp inside XWalk2?	N/A

Road Slope (%)	3.3	N/A	Clear Space?	N/A
	Road X Slope (%)	4.2	N/A	Clear Space to XWalk (in)	N/A
N/A	Any Obstructions?	N/A	N/A	Storm Grate/Utility Hazard?	N/A
	Obstruction Type			Storm Grate/Utility Type	
		N/A			N/A
			Yes	Surface Condition? (G/P)	Good
			N/A	Curb Slope (%)	16.5

Remove & Replace Curb Ramp With Two New Directional Ramps or Equivalent.
