Access Compliance Report

Public Rights-of-Way

(Curb Ramps)

Intersection ID: 8285	Main Street: CATHERINE_SIMMONS_AV	Cross Street: HAINES_ST	Location: S
ADA ID: 1554A0254F99	Ramp Type: Perp	Initial Pass/Fail: Pass	Overall Compliance: No
Codes/Mitigation Info/Possible Solution		Field Measurements/Component Compliance	
Severity Score: 15

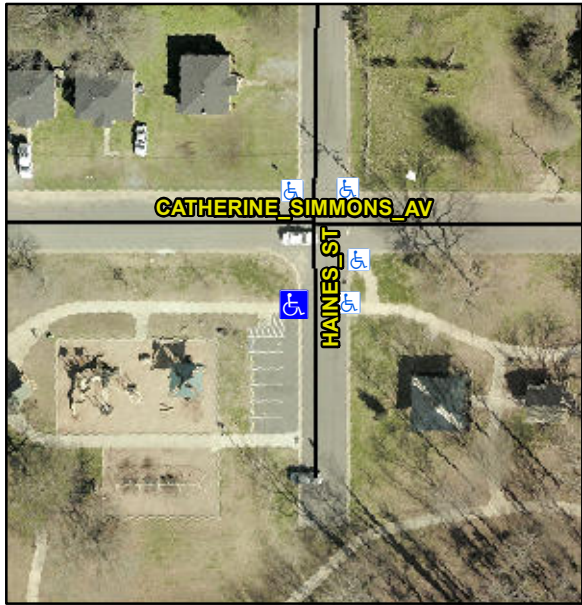
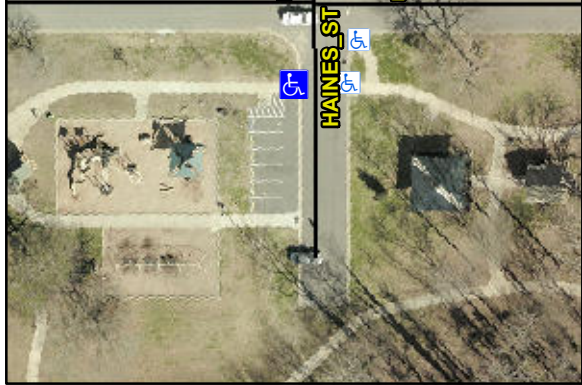
Not Found, R304.2.2-Perp, R304.3.2-Para, R304.5.3, R302.7.2							
	Street 1 Name	HAINES ST	Compliance	Description	Data	Compliance	Description	Data
	Stop Condition-Street 2	StopSign	N/A	Ramp Length (in)	16.5	Yes	Ramp Slope (%)	5.2
	Street 2 Name	N/A	Yes	Ramp Width (in)	48.0	Yes	Ramp XSlope (%)	2.0
	Stop Condition-Street 1	N/A	N/A	Flare Type LT	Sloped	N/A	Flare Type RT	N/A
		N/A	Flare Slope LT (%)	4.0	N/A	Flare Slope RT (%)	9.3	
		N/A	Flare Traversable LT?	Yes	N/A	Flare Traversable RT?	No	
		Yes	Landing Length (in)	80.5	Yes	DWS Provided?	Yes	
		Yes	Landing Width (in)	72.5	Yes	DWS Contrast?	Yes	
		No	Landing Slope (%)	2.1	Yes	DWS Length (in)	24.0	
		No	Landing X Slope (%)	2.8	Yes	DWS Full Width?	Yes	
		N/A	Landing Curb? (Y/N)	No	Yes	DWS Offset (in)	0.0	
		N/A	Shared Landing?	No				
		Yes	Gutter Ponding?	No	Yes	Gutter Slope (%)	1.2

No	Gutter Lip Ht (in)	2.0	Yes	Gutter X Slope (%)	0.6	
		N/A	Painted X Walk1?	No	N/A	Painted X Walk2?	N/A	
			X Walk 1 Direction	To E		X Walk 2 Direction	N/A	
		N/A	X Walk 1 Width (in)	N/A	N/A	X Walk 2 Width (in)	N/A	
			X Walk 1 Slope (%)	2.4		X Walk 2 Slope (%)	N/A	
			X Walk 1 X Slope (%)	1.5		X Walk 2 X Slope (%)	N/A	
		N/A	Ramp inside XWalk1?	N/A	N/A	Ramp inside XWalk2?	N/A	
			Road Slope (%)	N/A	N/A	Clear Space?	Yes	
			Road X Slope (%)	N/A	N/A	Clear Space to XWalk (in)	N/A	
		Yes	Any Obstructions?	No	Yes	Storm Grate/Utility Hazard?	No	
			Obstruction Type			Storm Grate/Utility Type		
					N/A		N/A	
					Yes	Surface Condition? (G/P)	Good	
Total Cost:		\$	1850.00

Possible Solutions:							
	Remove & Replace Entire Ramp.							
	Surveyor Notes:							
	N/A							
	PROW/ADA:
