Access Compliance Report

Public Rights-of-Way

(Curb Ramps)

| Intersection ID: 46144 | Main Street: EASTFIELD_VILLAGE_LN | Cross Street: ROCKY_FORD_CLUB_RD | Location: W |

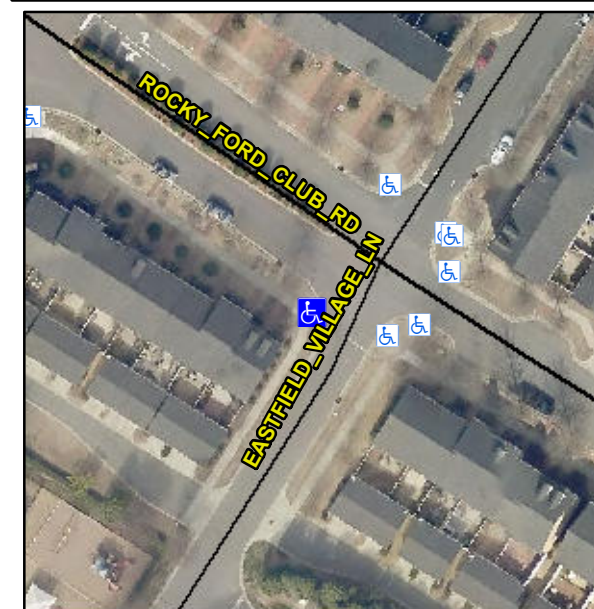
| ADA ID: 1554ED1E998F | Ramp Type: PerpDiag | Initial Pass/Fail: Fail | Overall Compliance: No |
| Severity Score: 13.75 | | | |

| Compliance | Description | Data | Compliance | Description | Data |
|---|---|---|---|---|---|
| N/A | Ramp Length (in) | 84.0 | No | Ramp Slope (%) | 8.6 |
| Yes | Ramp Width (in) | 48.0 | No | Ramp XSlope (%) | 4.7 |

Remove & Replace Curb Ramp With Two New Directional Ramps or Equivalent.

R304.2.2, R304.5.3
