Access Compliance Report

Public Rights-of-Way

(Curb Ramps)

Intersection ID: 18214	Main Street: FERNCLIFF_RD	Cross Street: PROVIDENCE_RD	Location: E
ADA ID: 155656BBC037	Ramp Type: PerpDiag	Initial Pass/Fail: Fail	Overall Compliance: No
Codes/Mitigation Info/Possible Solution		Field Measurements/Component Compliance	
Severity Score: 22.5

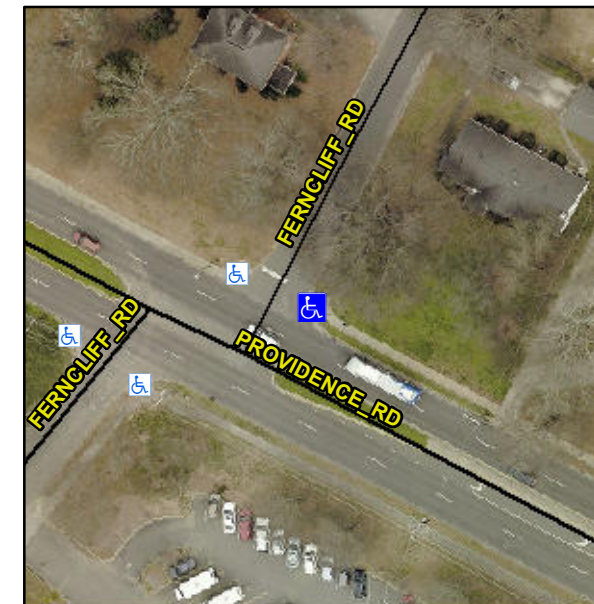
Not Found, R304.5.1, R304.2.2, R304.5.3

Compliance	Description	Data	Compliance	Description	Data
N/A	Ramp Length (in)	48.0	No	Ramp Slope (%)	9.1
No	Ramp Width (in)	39.0	No	Ramp XSlope (%)	3.0
N/A	Flare Type LT	N/A	N/A	Flare Type RT	N/A
N/A	Flare Slope LT (%)	N/A	N/A	Flare Slope RT (%)	N/A
N/A	Flare Traversable LT?	N/A	N/A	Flare Traversable RT?	N/A
N/A	Landing Length (in)	N/A	N/A	DWS Provided?	N/A
N/A	Landing Width (in)	N/A	N/A	DWS Contrast?	N/A
N/A	Landing Slope (%)	N/A	N/A	DWS Length (in)	N/A
N/A	Landing X Slope (%)	N/A	N/A	DWS Full Width?	N/A
N/A	Landing Curb? (Y/N)	N/A	N/A	DWS Offset (in)	N/A
N/A	Shared Landing?	N/A			
N/A	Gutter Ponding?	N/A	N/A	Gutter Slope (%)	N/A
N/A	Gutter Lip Ht (in)	N/A	N/A	Gutter X Slope (%)	N/A
N/A	Painted X Walk1?	No	N/A	Painted X Walk2?	No
	X Walk 1 Direction	To NW		X Walk 2 Direction	To SW
N/A	X Walk 1 Width (in)	N/A	N/A	X Walk 2 Width (in)	N/A
	X Walk 1 Slope (%)	2.9		X Walk 2 Slope (%)	1.8
	X Walk 1 X Slope (%)	1.0		X Walk 2 X Slope (%)	2.9

N/A	Ramp inside XWalk1?	N/A	N/A	Ramp inside XWalk2?	N/A
	Road Slope (%)	0.6	N/A	Clear Space?	N/A
	Road X Slope (%)	2.9	N/A	Clear Space to XWalk (in)	N/A
N/A	Any Obstructions?	N/A	N/A	Storm Grate/Utility Hazard?	N/A
	Obstruction Type			Storm Grate/Utility Type	
		N/A			N/A
			Yes	Surface Condition? (G/P)	Good

Remove & Replace Curb Ramp With Two New Directional Ramps or Equivalent.
