# Access Compliance Report

## Public Rights-of-Way

### (Curb Ramps)

Intersection ID: 43644	Main Street: CEDAR_CROSSINGS_DR	Cross Street: KENDRICK_CROSS_RD	Location: NW
ADA ID: 155DA5BE54AA	Ramp Type: Perp	Initial Pass/Fail: Fail	Overall Compliance: No
Severity Score: 12.5			
Codes/Mitigation Info/Possible Solution		Field Measurements/Component Compliance

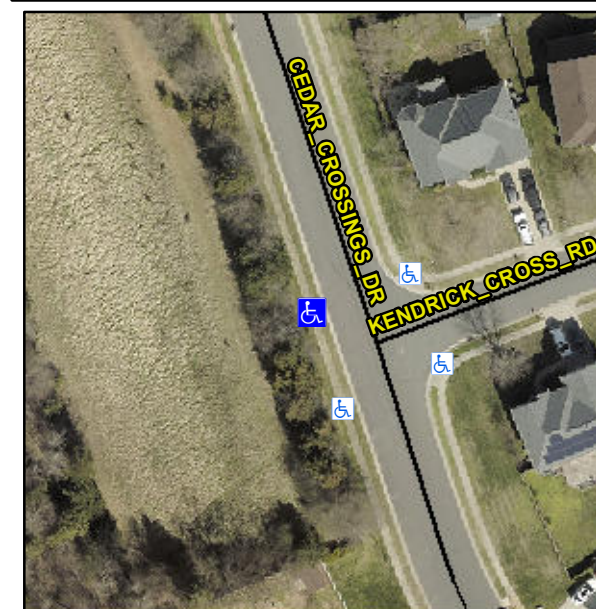
PROW/ADA:

**R304.2.2**

Compliance	Description	Data	Compliance	Description	Data
N/A	Ramp Length (in)	47.5	No	Ramp Slope (%)	10.9
Yes	Ramp Width (in)	48.0	Yes	Ramp XSlope (%)	0.3
N/A	Flare Type LT	N/A	N/A	Flare Type RT	N/A
N/A	Flare Slope LT (%)	N/A	N/A	Flare Slope RT (%)	N/A
N/A	Flare Traversable LT?	N/A	N/A	Flare Traversable RT?	N/A
N/A	Landing Length (in)	N/A	N/A	DWS Provided?	N/A
N/A	Landing Width (in)	N/A	N/A	DWS Contrast?	N/A
N/A	Landing Slope (%)	N/A	N/A	DWS Length (in)	N/A
N/A	Landing X Slope (%)	N/A	N/A	DWS Full Width?	N/A
N/A	Landing Curb? (Y/N)	N/A	N/A	DWS Offset (in)	N/A
N/A	Shared Landing?	N/A			
N/A	Gutter Ponding?	N/A	N/A	Gutter Slope (%)	N/A
N/A	Gutter Lip Ht (in)	N/A	N/A	Gutter X Slope (%)	N/A
N/A	Painted X Walk1?	No	N/A	Painted X Walk2?	N/A
	X Walk 1 Direction	To E		X Walk 2 Direction	N/A
N/A	X Walk 1 Width (in)	N/A	N/A	X Walk 2 Width (in)	N/A
	X Walk 1 Slope (%)	2.4		X Walk 2 Slope (%)	N/A
	X Walk 1 X Slope (%)	0.9		X Walk 2 X Slope (%)	N/A

Possible Solutions:

**Remove & Replace Entire Ramp.**

Total Cost: \$ 1850.00
