# Access Compliance Report

## Public Rights-of-Way

### (Curb Ramps)

Intersection ID: 11898	Main Street: ALLEN_ST	Cross Street: E_18TH_ST	Location: W
ADA ID: 1567D6BCB298	Ramp Type: Directional1	Initial Pass/Fail: Fail	Overall Compliance: No
		Severity Score: 1.25

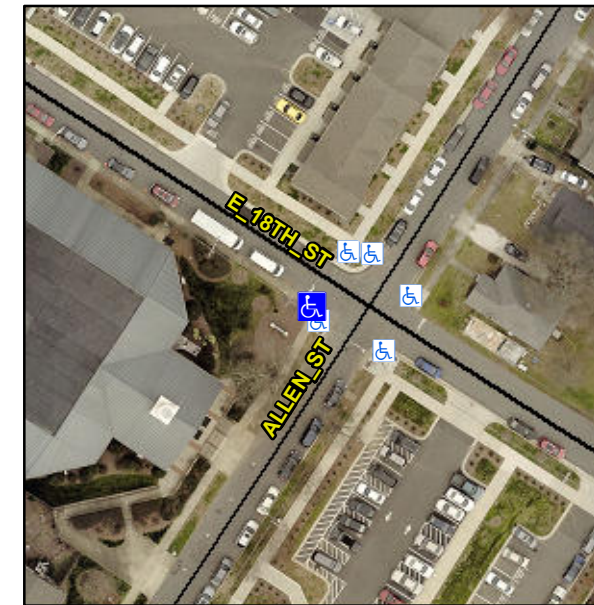
Compliance	Description	Data	Compliance	Description	Data
N/A	Ramp Length (in)	56.5	N/A	Grade Break?	N/A
Yes	Ramp Width (in)	57.0	N/A	Grade Break Slope (%)	0.0
Yes	Ramp Slope (%)	6.6	N/A	Grade Break XSlope (%)	0.0
No	Ramp XSlope (%)	3.3			
N/A	Flare Type LT	N/A	N/A	Flare Type RT	N/A
N/A	Flare Slope LT (%)	N/A	N/A	Flare Slope RT (%)	0.0
N/A	Flare Traversable LT?	N/A	N/A	Flare Traversable RT?	N/A
N/A	Landing Length (in)	0.0	N/A	DWS Provided?	N/A
N/A	Landing Width (in)	0.0	N/A	DWS Contrast?	N/A
N/A	Landing Slope (%)	0.0	N/A	DWS Length (in)	N/A
N/A	Landing X Slope (%)	0.0	N/A	DWS Full Width?	N/A
N/A	Landing Curb? (Y/N)	N/A	N/A	DWS Offset LT (in)	N/A
N/A	Shared Landing?	N/A	N/A	DWS Offset RT (in)	N/A
N/A	Gutter Ponding?	0.0	N/A	Gutter Slope (%)	N/A
N/A	Gutter Lip Ht (in)	0.0	N/A	Gutter X Slope (%)	N/A
N/A	Painted X Walk1?	No		Road Slope (%)	2.7
	X Walk 1 Direction	To NE		Road X Slope (%)	2.1
	X Walk 1 Width (in)	N/A		Clear Space?	N/A

X Walk 1 Slope (%)	2.7	N/A	Clear Space to XWalk (in)	N/A
	X Walk 1 X Slope (%)	2.1	N/A	Storm Grate/Utility Hazard?	N/A
N/A	Ramp inside XWalk1?	N/A		Storm Grate/Utility Type	
N/A	Any Obstructions?	N/A			N/A
	Obstruction Type		Yes	Surface Condition? (G/P)	Good
			N/A	Curb Slope (%)	7.9

**Remove & Replace Entire Ramp.**
