Access Compliance Report

Public Rights-of-Way

(Curb Ramps)

Intersection ID: 51508	Main Street: ALDERSON_DR	Cross Street: EASTFIELD_RD	Location: S
ADA ID: 15686CA6B248	Ramp Type: Perp	Initial Pass/Fail: Fail	Overall Compliance: No
Severity Score: 1.25			
Codes/Mitigation Info/Possible Solution		Field Measurements/Component Compliance

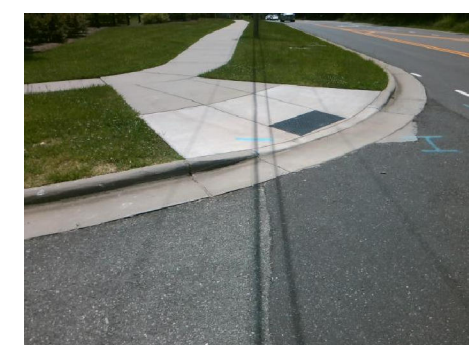
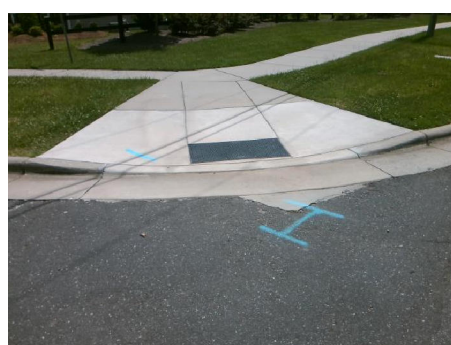
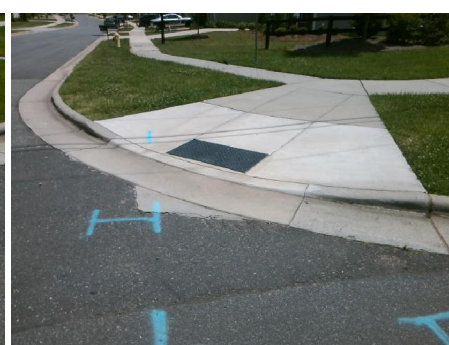
R304.5.3

Compliance	Description	Data	Compliance	Description	Data
N/A	Ramp Length (in)	170.0	Yes	Ramp Slope (%)	7.2
Yes	Ramp Width (in)	48.0	No	Ramp XSlope (%)	2.2
N/A	Flare Type LT	N/A	N/A	Flare Type RT	N/A
N/A	Flare Slope LT (%)	N/A	N/A	Flare Slope RT (%)	N/A
N/A	Flare Traversable LT?	N/A	N/A	Flare Traversable RT?	N/A
N/A	Landing Length (in)	N/A	N/A	DWS Provided?	N/A
N/A	Landing Width (in)	N/A	N/A	DWS Contrast?	N/A
N/A	Landing Slope (%)	N/A	N/A	DWS Length (in)	N/A
N/A	Landing X Slope (%)	N/A	N/A	DWS Full Width?	N/A
N/A	Landing Curb? (Y/N)	N/A	N/A	DWS Offset (in)	N/A
N/A	Shared Landing?	N/A			
N/A	Gutter Ponding?	N/A	N/A	Gutter Slope (%)	N/A
N/A	Gutter Lip Ht (in)	N/A	N/A	Gutter X Slope (%)	N/A
N/A	Painted X Walk1?	No	N/A	Painted X Walk2?	N/A
	X Walk 1 Direction	To NE		X Walk 2 Direction	N/A
N/A	X Walk 1 Width (in)	N/A	N/A	X Walk 2 Width (in)	N/A
	X Walk 1 Slope (%)	4.0		X Walk 2 Slope (%)	N/A
	X Walk 1 X Slope (%)	0.4		X Walk 2 X Slope (%)	N/A

N/A	Ramp inside XWalk1?	N/A	N/A	Ramp inside XWalk2?	N/A
	Road Slope (%)	N/A	N/A	Clear Space?	N/A
	Road X Slope (%)	N/A	N/A	Clear Space to XWalk (in)	N/A
N/A	Any Obstructions?	N/A	N/A	Storm Grate/Utility Hazard?	N/A
	Obstruction Type			Storm Grate/Utility Type	
		N/A			N/A
			Yes	Surface Condition? (G/P)	Good

Remove & Replace Entire Ramp.

\$ 1850.00
