# Access Compliance Report

## Public Rights-of-Way

### (Curb Ramps)

| Intersection ID: 30327 | Main Street: FLYING_SCOTSMAN_DR | Cross Street: STOURBRIDGE_LION_DR | Location: N |

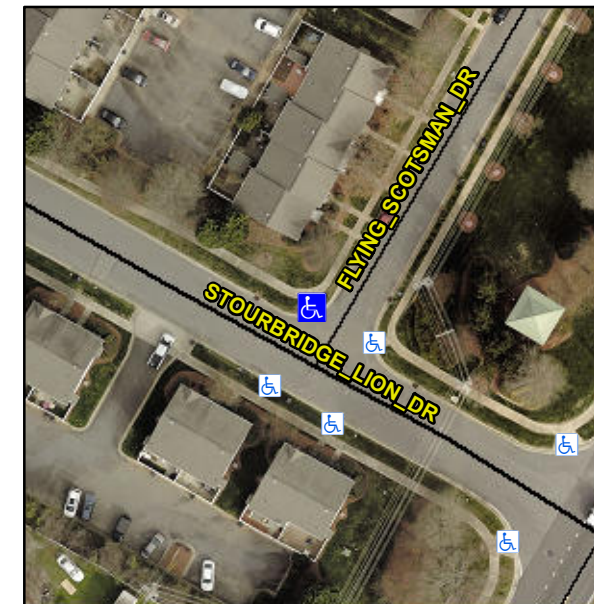
**CURB LIP 1.0**

**Not Found, R304.5.3, R304.2.1, R304.2.2-Perp, R304.3.2-Para, R305**

**Remove & Replace Curb Ramp With Two New Directional Ramps or Equivalent. Remove & Replace Gutter.**

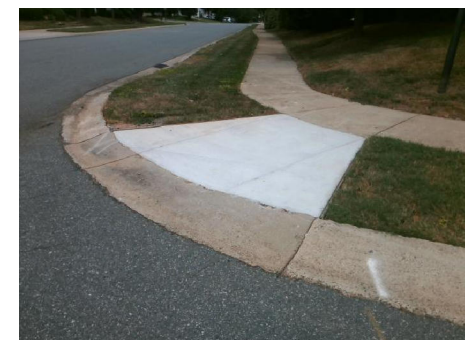
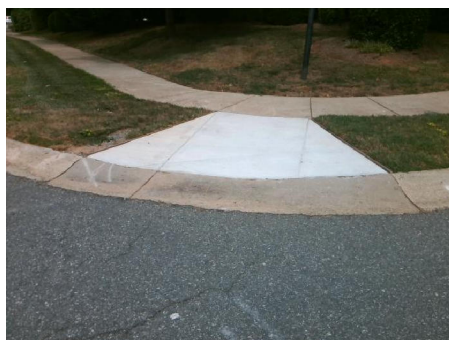
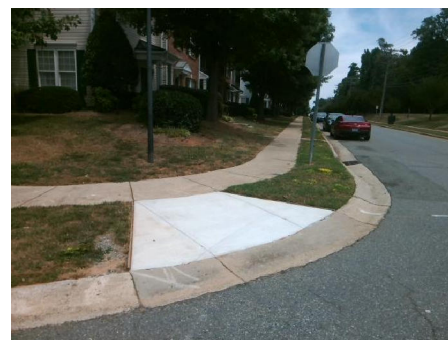
| Compliance | Description | Data | Compliance | Description | Data |
|---|---|---|---|---|---|
| Yes | Ramp Width (in) | 54.0 | No | BlendTrans XSlope (%) | 3.7 |
| No | Landing Width (in) | 40.0 | N/A | DWS Contrast? | No |
| No | Landing Slope (%) | 2.5 | N/A | DWS Length (in) | N/A |
| No | Landing X Slope (%) | 3.8 | N/A | DWS Full Width? | No |
| Yes | Gutter Lip Ht (in) | 0.0 | No | Gutter X Slope (%) | 3.4 |
