Access Compliance Report

Public Rights-of-Way

(Curb Ramps)

Intersection ID: 14621	Main Street: KENMORE_AV	Cross Street: N_LAUREL_AV	Location: NE
ADA ID: 15754AF00B04	Ramp Type: PerpDiag	Initial Pass/Fail: Fail	Overall Compliance: No
		Severity Score: 12.5

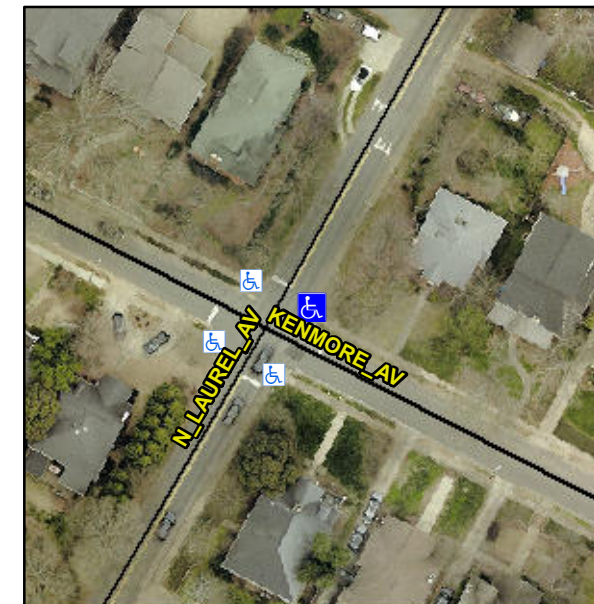
Compliance	Description	Data	Compliance	Description	Data
N/A	Ramp Length (in)	36.0	Yes	Ramp Slope (%)	7.4
Yes	Ramp Width (in)	48.0	No	Ramp XSlope (%)	6.5
N/A	Flare Type LT	N/A	N/A	Flare Type RT	N/A
N/A	Flare Slope LT (%)	N/A	N/A	Flare Slope RT (%)	N/A
N/A	Flare Traversable LT?	N/A	N/A	Flare Traversable RT?	N/A
N/A	Landing Length (in)	N/A	N/A	DWS Provided?	N/A
N/A	Landing Width (in)	N/A	N/A	DWS Contrast?	N/A
N/A	Landing Slope (%)	N/A	N/A	DWS Length (in)	N/A
N/A	Landing X Slope (%)	N/A	N/A	DWS Full Width?	N/A
N/A	Landing Curb? (Y/N)	N/A	N/A	DWS Offset (in)	N/A
N/A	Shared Landing?	N/A			
N/A	Gutter Ponding?	N/A	N/A	Gutter Slope (%)	N/A
N/A	Gutter Lip Ht (in)	N/A	N/A	Gutter X Slope (%)	N/A
N/A	Painted X Walk1?	No	N/A	Painted X Walk2?	No
	X Walk 1 Direction	To NW		X Walk 2 Direction	To SW
N/A	X Walk 1 Width (in)	N/A	N/A	X Walk 2 Width (in)	N/A
	X Walk 1 Slope (%)	17.3		X Walk 2 Slope (%)	3.8
	X Walk 1 X Slope (%)	0.6		X Walk 2 X Slope (%)	8.1

N/A	Ramp inside XWalk1?	N/A	N/A	Ramp inside XWalk2?	N/A
	Road Slope (%)	3.6	N/A	Clear Space?	N/A
	Road X Slope (%)	13.2	N/A	Clear Space to XWalk (in)	N/A
N/A	Any Obstructions?	N/A	N/A	Storm Grate/Utility Hazard?	N/A
	Obstruction Type			Storm Grate/Utility Type	
		N/A			N/A
			Yes	Surface Condition? (G/P)	Good

Remove & Replace Curb Ramp With Two New Directional Ramps or Equivalent.

R304.5.3
