# Access Compliance Report

## Public Rights-of-Way

Intersection ID: 4075	Main Street: OVERLOOK_MOUNTAIN_DR	Cross Street: MOUNTAIN_COVE_DR	Location: SE
ADA ID: 157734330C2C	Ramp Type: PerpDiag	Initial Pass/Fail: Fail	Overall Compliance: No
Severity Score: 33.75			
Codes/Mitigation Info/Possible Solution		Field Measurements/Component Compliance

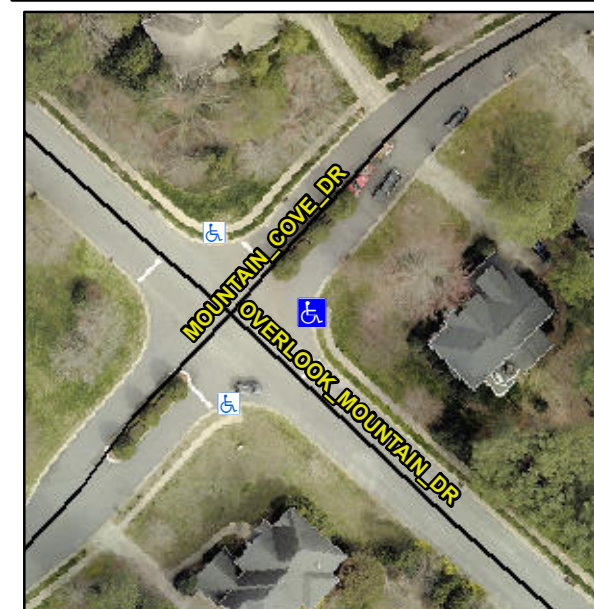
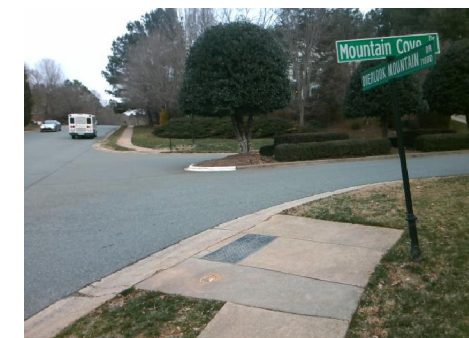
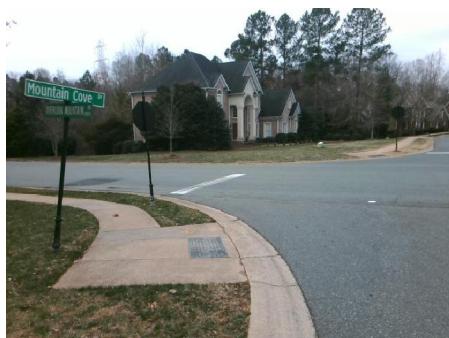
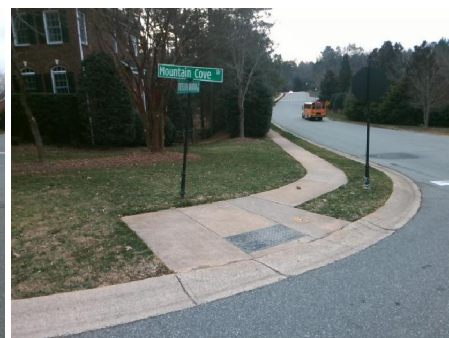
**Not Found, R304.5.1, R304.5.3**

Compliance	Description	Data	Compliance	Description	Data
N/A	Ramp Length (in)	96.0	Yes	Ramp Slope (%)	5.0
No	Ramp Width (in)	44.0	No	Ramp XSlope (%)	7.8
N/A	Flare Type LT	N/A	N/A	Flare Type RT	N/A
N/A	Flare Slope LT (%)	N/A	N/A	Flare Slope RT (%)	N/A
N/A	Flare Traversable LT?	N/A	N/A	Flare Traversable RT?	N/A
N/A	Landing Length (in)	N/A	N/A	DWS Provided?	N/A
N/A	Landing Width (in)	N/A	N/A	DWS Contrast?	N/A
N/A	Landing Slope (%)	N/A	N/A	DWS Length (in)	N/A
N/A	Landing X Slope (%)	N/A	N/A	DWS Full Width?	N/A
N/A	Landing Curb? (Y/N)	N/A	N/A	DWS Offset (in)	N/A
N/A	Shared Landing?	N/A			
N/A	Gutter Ponding?	N/A	N/A	Gutter Slope (%)	N/A
N/A	Gutter Lip Ht (in)	N/A	N/A	Gutter X Slope (%)	N/A
N/A	Painted X Walk1?	No	N/A	Painted X Walk2?	No
	X Walk 1 Direction	To NW		X Walk 2 Direction	To SW
N/A	X Walk 1 Width (in)	N/A	N/A	X Walk 2 Width (in)	N/A
	X Walk 1 Slope (%)	6.0		X Walk 2 Slope (%)	1.4
	X Walk 1 X Slope (%)	4.8		X Walk 2 X Slope (%)	6.0

N/A	Ramp inside XWalk1?	N/A	N/A	Ramp inside XWalk2?	N/A
	Road Slope (%)	6.4	N/A	Clear Space?	N/A
	Road X Slope (%)	4.2	N/A	Clear Space to XWalk (in)	N/A
N/A	Any Obstructions?	N/A	N/A	Storm Grate/Utility Hazard?	N/A
	Obstruction Type			Storm Grate/Utility Type	
		N/A			N/A
			Yes	Surface Condition? (G/P)	Good

**Remove & Replace Curb Ramp With Two New Directional Ramps or Equivalent.**
