# Access Compliance Report

## Public Rights-of-Way

| Intersection ID: 6474 | Main Street: CENTURY_OAKS_LN | Cross Street: FALLEN_TREE_CT | Location: NE |
| ADA ID: 15789D472D03 | Ramp Type: Perp | Initial Pass/Fail: Fail | Overall Compliance: No |

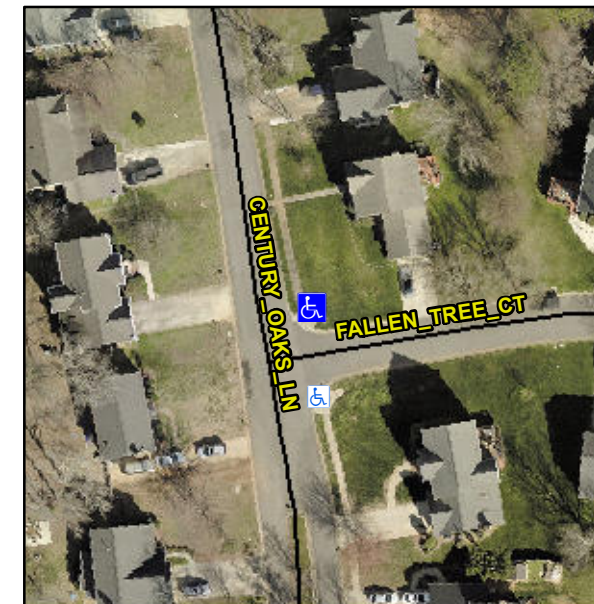
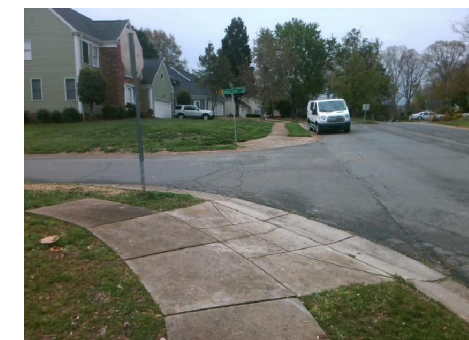
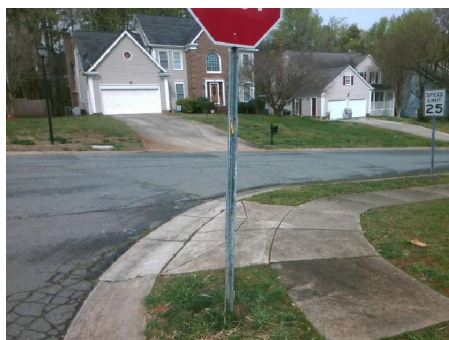
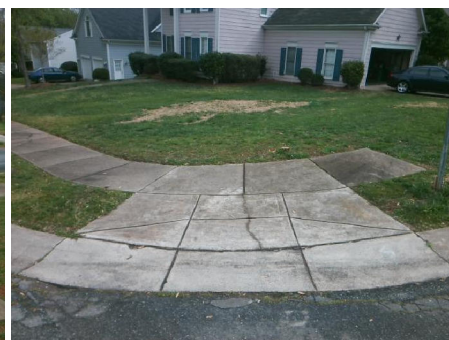
| Severity Score: 33.75 | | | |

**R304.5.1, R304.5.3**

| Compliance | Description | Data | Compliance | Description | Data |
|---|---|---|---|---|---|
| No | Ramp Width (in) | 44.0 | No | Ramp XSlope (%) | 7.6 |

**Remove & Replace Entire Ramp.**

Total Cost: \$ 1850.00
