Access Compliance Report

Public Rights-of-Way

(Curb Ramps)

Intersection ID: 48451	Main Street: RED_RUST_LN	Cross Street: DANCING_WIND_RD	Location: NW
ADA ID: 158222D93BD0	Ramp Type: Perp	Initial Pass/Fail: Fail	Overall Compliance: No
		Severity Score: 8.75

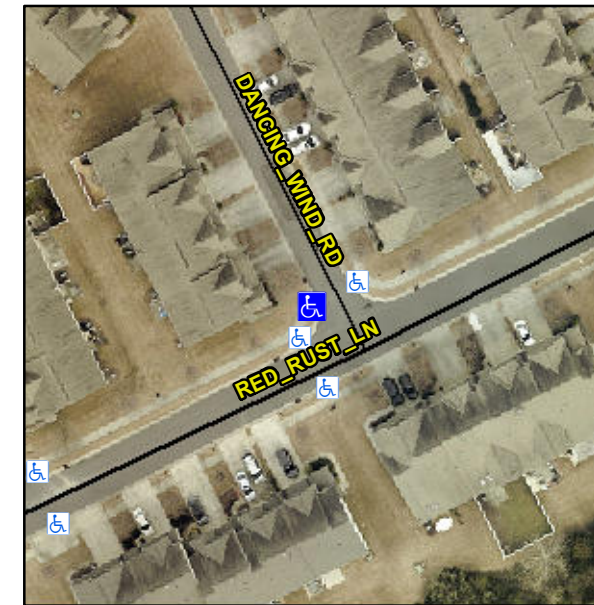
Not Found, R304.5.1

Compliance	Description	Data	Compliance	Description	Data
N/A	Ramp Length (in)	47.0	Yes	Ramp Slope (%)	5.2
No	Ramp Width (in)	47.0	Yes	Ramp XSlope (%)	0.7
N/A	Flare Type LT	N/A	N/A	Flare Type RT	N/A
N/A	Flare Slope LT (%)	N/A	N/A	Flare Slope RT (%)	N/A
N/A	Flare Traversable LT?	N/A	N/A	Flare Traversable RT?	N/A
N/A	Landing Length (in)	N/A	N/A	DWS Provided?	N/A
N/A	Landing Width (in)	N/A	N/A	DWS Contrast?	N/A
N/A	Landing Slope (%)	N/A	N/A	DWS Length (in)	N/A
N/A	Landing X Slope (%)	N/A	N/A	DWS Full Width?	N/A
N/A	Landing Curb? (Y/N)	N/A	N/A	DWS Offset (in)	N/A
N/A	Shared Landing?	N/A			
N/A	Gutter Ponding?	N/A	N/A	Gutter Slope (%)	N/A
N/A	Gutter Lip Ht (in)	N/A	N/A	Gutter X Slope (%)	N/A
N/A	Painted X Walk1?	No	N/A	Painted X Walk2?	N/A
	X Walk 1 Direction	To NE		X Walk 2 Direction	N/A
N/A	X Walk 1 Width (in)	N/A	N/A	X Walk 2 Width (in)	N/A
	X Walk 1 Slope (%)	2.2		X Walk 2 Slope (%)	N/A
	X Walk 1 X Slope (%)	0.3		X Walk 2 X Slope (%)	N/A

N/A	Ramp inside XWalk1?	N/A	N/A	Ramp inside XWalk2?	N/A
	Road Slope (%)	N/A	N/A	Clear Space?	N/A
	Road X Slope (%)	N/A	N/A	Clear Space to XWalk (in)	N/A
N/A	Any Obstructions?	N/A	N/A	Storm Grate/Utility Hazard?	N/A
	Obstruction Type			Storm Grate/Utility Type	
		N/A			N/A
			Yes	Surface Condition? (G/P)	Good

Remove & Replace Entire Ramp.
