Access Compliance Report

Public Rights-of-Way

(Curb Ramps)

Intersection ID: 8228	Main Street: CROSSRIDGE_RD	Cross Street: SULLINS_RD	Location:	S
ADA ID: 15930554EC97	Ramp Type: Perp	Initial Pass/Fail: Fail	Overall Compliance: No	Severity Score: 10
Codes/Mitigation Info/Possible Solution		Field Measurements/Component Compliance

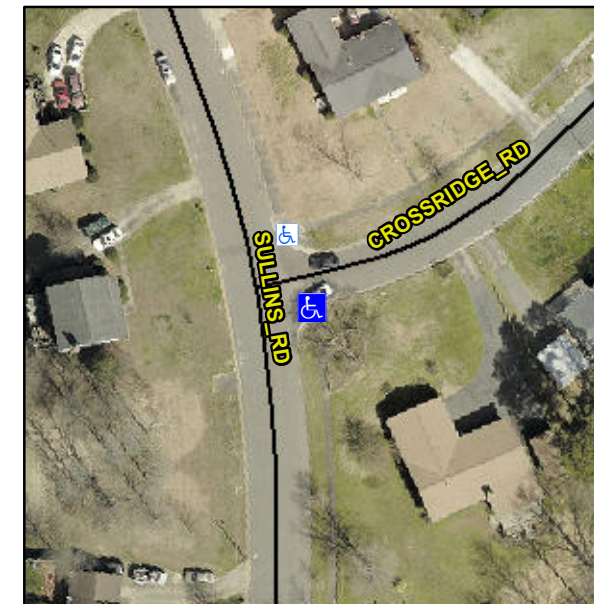
Not Found, R304.5.1, R304.5.3

Compliance	Description	Data	Compliance	Description	Data
N/A	Ramp Length (in)	58.0	Yes	Ramp Slope (%)	7.2
No	Ramp Width (in)	37.0	No	Ramp XSlope (%)	4.7
N/A	Flare Type LT	N/A	N/A	Flare Type RT	N/A
N/A	Flare Slope LT (%)	N/A	N/A	Flare Slope RT (%)	N/A
N/A	Flare Traversable LT?	N/A	N/A	Flare Traversable RT?	N/A
N/A	Landing Length (in)	N/A	N/A	DWS Provided?	N/A
N/A	Landing Width (in)	N/A	N/A	DWS Contrast?	N/A
N/A	Landing Slope (%)	N/A	N/A	DWS Length (in)	N/A
N/A	Landing X Slope (%)	N/A	N/A	DWS Full Width?	N/A
N/A	Landing Curb? (Y/N)	N/A	N/A	DWS Offset (in)	N/A
N/A	Shared Landing?	N/A			
N/A	Gutter Ponding?	N/A	N/A	Gutter Slope (%)	N/A
N/A	Gutter Lip Ht (in)	0.5	N/A	Gutter X Slope (%)	N/A
N/A	Painted X Walk1?	No	N/A	Painted X Walk2?	N/A
	X Walk 1 Direction	To N		X Walk 2 Direction	N/A
N/A	X Walk 1 Width (in)	N/A	N/A	X Walk 2 Width (in)	N/A
	X Walk 1 Slope (%)	3.7		X Walk 2 Slope (%)	N/A
	X Walk 1 X Slope (%)	1.3		X Walk 2 X Slope (%)	N/A

N/A	Ramp inside XWalk1?	N/A	N/A	Ramp inside XWalk2?	N/A
	Road Slope (%)	N/A	N/A	Clear Space?	N/A
	Road X Slope (%)	N/A	N/A	Clear Space to XWalk (in)	N/A
N/A	Any Obstructions?	N/A	N/A	Storm Grate/Utility Hazard?	N/A
	Obstruction Type			Storm Grate/Utility Type	
		N/A			N/A
			Yes	Surface Condition? (G/P)	Good

Possible Solutions:

Remove & Replace Entire Ramp.
