Access Compliance Report

Public Rights-of-Way

(Curb Ramps)

Intersection ID: 8390	Main Street: LASALLE_ST	Cross Street: SYRACUSE_DR	Location: W
ADA ID: 1596E703D78D	Ramp Type: Perp	Initial Pass/Fail: Fail	Overall Compliance: No
Codes/Mitigation Info/Possible Solution			Severity Score: 10
			Field Measurements/Component Compliance

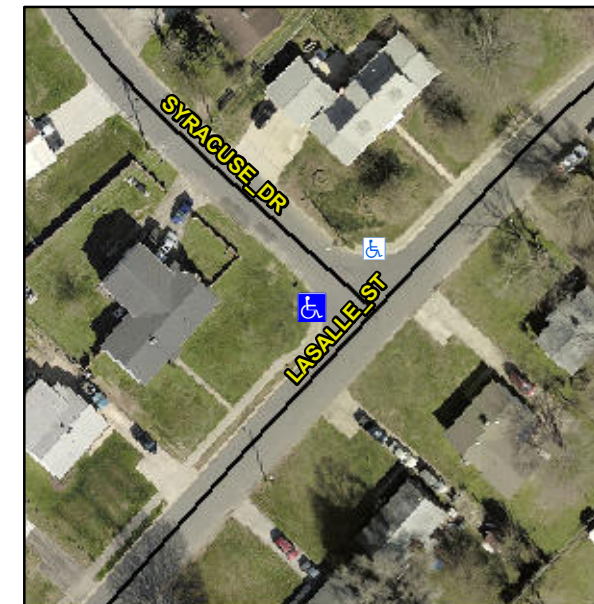
Compliance	Description	Data	Compliance	Description	Data
N/A	Ramp Length (in)	36.5	Yes	Ramp Slope (%)	5.9
No	Ramp Width (in)	41.0	No	Ramp XSlope (%)	2.9
N/A	Flare Type LT	N/A	N/A	Flare Type RT	N/A
N/A	Flare Slope LT (%)	N/A	N/A	Flare Slope RT (%)	N/A
N/A	Flare Traversable LT?	N/A	N/A	Flare Traversable RT?	N/A
N/A	Landing Length (in)	N/A	N/A	DWS Provided?	N/A
N/A	Landing Width (in)	N/A	N/A	DWS Contrast?	N/A
N/A	Landing Slope (%)	N/A	N/A	DWS Length (in)	N/A
N/A	Landing X Slope (%)	N/A	N/A	DWS Full Width?	N/A
N/A	Landing Curb? (Y/N)	N/A	N/A	DWS Offset (in)	N/A
N/A	Shared Landing?	N/A			
N/A	Gutter Ponding?	N/A	N/A	Gutter Slope (%)	N/A
N/A	Gutter Lip Ht (in)	N/A	N/A	Gutter X Slope (%)	N/A
N/A	Painted X Walk1?	No	N/A	Painted X Walk2?	N/A
	X Walk 1 Direction	To NE		X Walk 2 Direction	N/A
N/A	X Walk 1 Width (in)	N/A	N/A	X Walk 2 Width (in)	N/A
	X Walk 1 Slope (%)	4.8		X Walk 2 Slope (%)	N/A
	X Walk 1 X Slope (%)	1.0		X Walk 2 X Slope (%)	N/A

N/A	Ramp inside XWalk1?	N/A	N/A	Ramp inside XWalk2?	N/A
	Road Slope (%)	N/A	N/A	Clear Space?	N/A
	Road X Slope (%)	N/A	N/A	Clear Space to XWalk (in)	N/A
N/A	Any Obstructions?	N/A	N/A	Storm Grate/Utility Hazard?	N/A
	Obstruction Type			Storm Grate/Utility Type	
		N/A			N/A
			Yes	Surface Condition? (G/P)	Good

Possible Solutions:

Remove & Replace Entire Ramp.

R304.5.1, R304.5.3
