Access Compliance Report

Public Rights-of-Way

(Curb Ramps)

Intersection ID: 13402	Main Street: S_MINT_ST	Cross Street: SPRUCE_ST	Location: NW
ADA ID: 159C205B66F3	Ramp Type: ParaDiag	Initial Pass/Fail: Fail	Overall Compliance: No
			Severity Score: 13.75

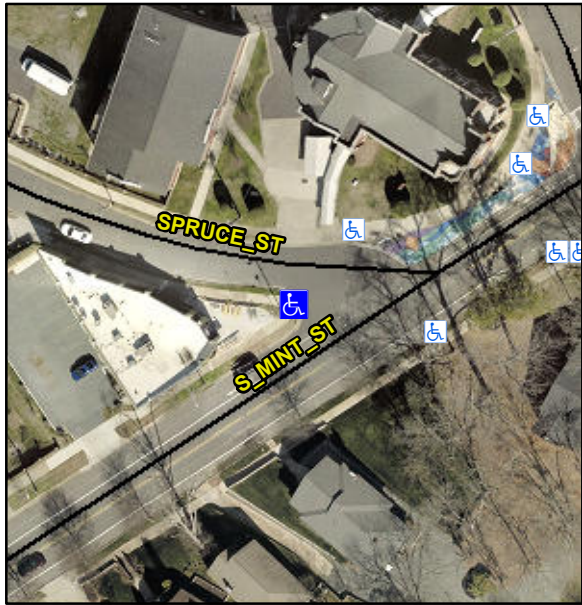
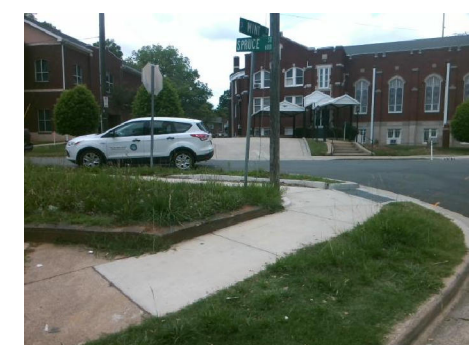
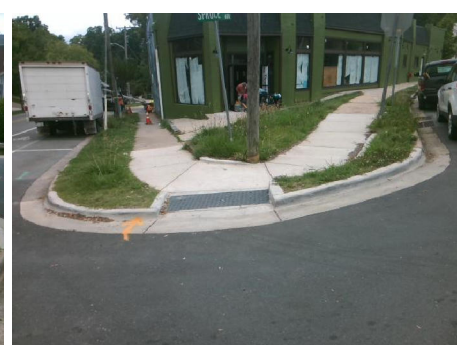
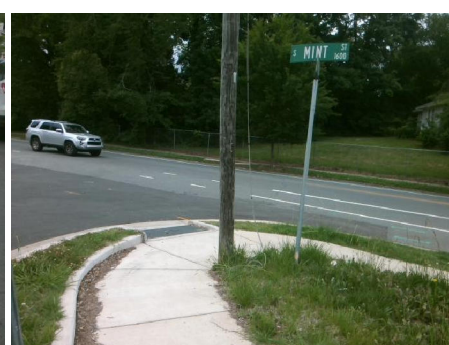
Possible Solutions:		Compliance	Description	Data	Compliance	Description	Data
	Remove & Replace Curb Ramp With Two New Directional Ramps or Equivalent.		N/A	Ramp Length LT (in)	131.5	N/A	Ramp Length RT (in)	108.0
			Yes	Ramp Width LT (in)	58.0	Yes	Ramp Width RT (in)	60.0
			No	Ramp Slope LT (%)	8.8	Yes	Ramp Slope RT (%)	7.9
			No	Ramp XSlope LT (%)	3.3	No	Ramp XSlope RT (%)	2.6
			N/A	Landing Length (in)	N/A	N/A	DWS Provided?	N/A
			N/A	Landing Width (in)	N/A	N/A	DWS Contrast?	N/A
			N/A	Landing Slope (%)	N/A	N/A	DWS Length (in)	N/A
			N/A	Landing X Slope (%)	N/A	N/A	DWS Full Width?	N/A
			N/A	Landing Curb? (Y/N)	N/A	N/A	DWS Offset (in)	N/A
Surveyor Notes:			N/A	Shared Landing?	N/A			
PROW/ADA:			N/A	Gutter Ponding?	N/A	N/A	Gutter Slope (%)	N/A
			N/A	Gutter Lip Ht (in)	N/A	N/A	Gutter X Slope (%)	N/A
			N/A	Painted X Walk1?	No	N/A	Painted X Walk2?	No

X Walk 1 Direction	To SE		X Walk 2 Direction	To NE
			N/A	X Walk 1 Width (in)	N/A	N/A	X Walk 2 Width (in)	N/A
				X Walk 1 Slope (%)	0.6		X Walk 2 Slope (%)	10.3
				X Walk 1 X Slope (%)	8.1		X Walk 2 X Slope (%)	3.7
			N/A	Ramp inside XWalk1?	N/A	N/A	Ramp inside XWalk2?	N/A
				Road Slope (%)	6.1	N/A	Clear Space?	N/A
				Road X Slope (%)	10.1	N/A	Clear Space to XWalk (in)	N/A
			N/A	Any Obstructions?	N/A	N/A	Storm Grate/Utility Hazard?	N/A
				Obstruction Type			Storm Grate/Utility Type	
					N/A			N/A
						Yes	Surface Condition? (G/P)	Good
						N/A	Curb Slope (%)	9.3
Street 1 Name		S MINT ST						
Stop Condition-Street 1		None						
Street 2 Name		SPRUCE ST						
Stop Condition-Street 2		StopSign						
Total Cost:		\$ 3200.00
