Access Compliance Report

(Curb Ramps)

Intersection ID: 14655	Main Street: CAMERON_AV	Cross Street: E_5TH_ST	Location: NE
ADA ID: 15A27C165DAF	Ramp Type: BlendTrans1	Initial Pass/Fail: Fail	Overall Compliance: No
		Severity Score: 1.25

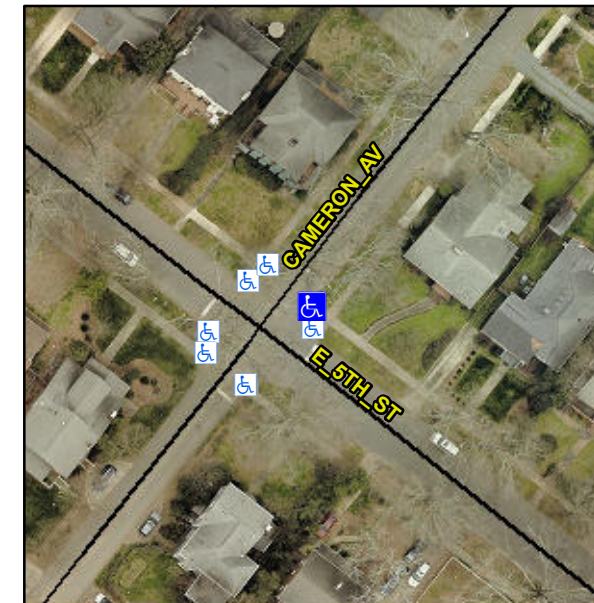
Compliance	Description	Data	Compliance	Description	Data
N/A	Ramp Length (in)	64.0	Yes	BlendTrans Slope (%)	3.6
Yes	Ramp Width (in)	48.0	No	BlendTrans XSlope (%)	2.8
N/A	Flare Type LT	N/A	N/A	Flare Type RT	N/A
N/A	Flare Slope LT (%)	N/A	N/A	Flare Slope RT (%)	N/A
N/A	Flare Traversable LT?	N/A	N/A	Flare Traversable RT?	N/A
N/A	Landing Length (in)	N/A	N/A	DWS Provided?	N/A
N/A	Landing Width (in)	N/A	N/A	DWS Contrast?	N/A
N/A	Landing Slope (%)	N/A	N/A	DWS Length (in)	N/A
N/A	Landing X Slope (%)	N/A	N/A	DWS Full Width?	N/A
N/A	Landing Curb? (Y/N)	N/A	N/A	DWS Offset (in)	N/A
N/A	Shared Landing?	N/A			
N/A	Gutter Ponding?	N/A	N/A	Gutter Slope (%)	N/A
N/A	Gutter Lip Ht (in)	N/A	N/A	Gutter X Slope (%)	N/A
N/A	Painted X Walk1?	No	N/A	Painted X Walk2?	N/A
	X Walk 1 Direction	To NW		X Walk 2 Direction	N/A
	X Walk 1 Width (in)	N/A		X Walk 2 Width (in)	N/A
	X Walk 1 Slope (%)	2.6		X Walk 2 Slope (%)	N/A
	X Walk 1 X Slope (%)	1.6		X Walk 2 X Slope (%)	N/A

N/A	Ramp inside XWalk1?	N/A	N/A	Ramp inside XWalk2?	N/A
	Road Slope (%)	1.6		Clear Space?	N/A
	Road X Slope (%)	2.6	N/A	Clear Space to XWalk (in)	N/A
N/A	Any Obstructions?	N/A	N/A	Storm Grate/Utility Hazard?	N/A
	Obstruction Type			Storm Grate/Utility Type	
		N/A			N/A
			Yes	Surface Condition? (G/P)	Good
			N/A	Curb Slope (%)	1.8

Possible Solutions:

Remove & Replace Curb Ramp With Two New Directional Ramps or Equivalent.

R304.5.3
