# Access Compliance Report

## Public Rights-of-Way

### (Curb Ramps)

Intersection ID: 13487	Main Street: S_MINT_ST	Cross Street: W_KINGSTON_AV	Location: SW
ADA ID: 15B4FC5F0505	Ramp Type: Perp	Initial Pass/Fail: Fail	Overall Compliance: No
Severity Score: 12.5			
Codes/Mitigation Info/Possible Solution		Field Measurements/Component Compliance

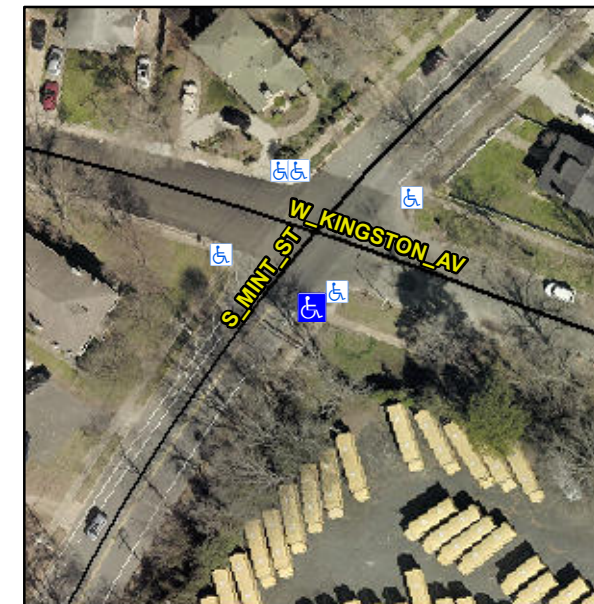
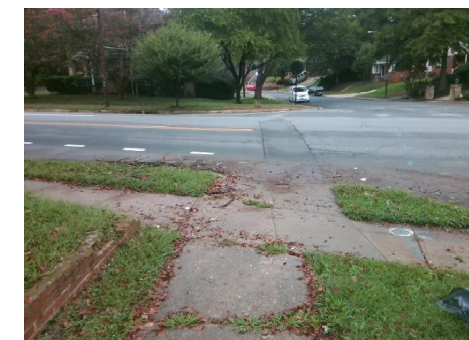
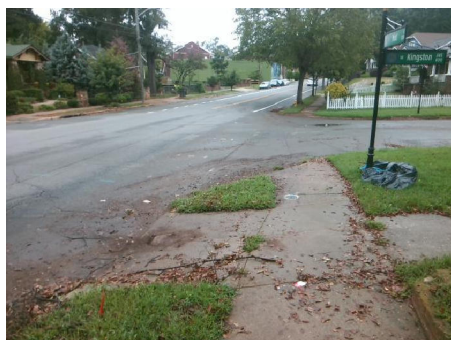
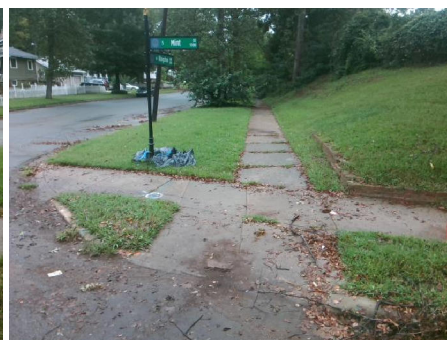
**Not Found, R304.5.3**

Compliance	Description	Data	Compliance	Description	Data
N/A	Ramp Length (in)	116.0	Yes	Ramp Slope (%)	6.1
Yes	Ramp Width (in)	48.0	No	Ramp XSlope (%)	5.8
N/A	Flare Type LT	N/A	N/A	Flare Type RT	N/A
N/A	Flare Slope LT (%)	N/A	N/A	Flare Slope RT (%)	N/A
N/A	Flare Traversable LT?	N/A	N/A	Flare Traversable RT?	N/A
N/A	Landing Length (in)	N/A	N/A	DWS Provided?	N/A
N/A	Landing Width (in)	N/A	N/A	DWS Contrast?	N/A
N/A	Landing Slope (%)	N/A	N/A	DWS Length (in)	N/A
N/A	Landing X Slope (%)	N/A	N/A	DWS Full Width?	N/A
N/A	Landing Curb? (Y/N)	N/A	N/A	DWS Offset (in)	N/A
N/A	Shared Landing?	N/A			
N/A	Gutter Ponding?	N/A	N/A	Gutter Slope (%)	N/A
N/A	Gutter Lip Ht (in)	N/A	N/A	Gutter X Slope (%)	N/A
N/A	Painted X Walk1?	No	N/A	Painted X Walk2?	N/A
	X Walk 1 Direction	To NW		X Walk 2 Direction	N/A
N/A	X Walk 1 Width (in)	N/A	N/A	X Walk 2 Width (in)	N/A
	X Walk 1 Slope (%)	5.0		X Walk 2 Slope (%)	N/A
	X Walk 1 X Slope (%)	0.1		X Walk 2 X Slope (%)	N/A

N/A	Ramp inside XWalk1?	N/A	N/A	Ramp inside XWalk2?	N/A
	Road Slope (%)	N/A	N/A	Clear Space?	N/A
	Road X Slope (%)	N/A	N/A	Clear Space to XWalk (in)	N/A
N/A	Any Obstructions?	N/A	N/A	Storm Grate/Utility Hazard?	N/A
	Obstruction Type			Storm Grate/Utility Type	
		N/A			N/A
		Yes		Surface Condition? (G/P)	Good

**Remove & Replace Entire Ramp.**
