Access Compliance Report

Public Rights-of-Way

(Curb Ramps)

Intersection ID: 8262	Main Street: HOVIS_RD	Cross Street: MARBLE_ST	Location: NW
ADA ID: 15BD9F198681	Ramp Type: Combination2	Initial Pass/Fail: Fail	Overall Compliance: No
Codes/Mitigation Info/Possible Solution		Field Measurements/Component Compliance	
Severity Score: 1.25

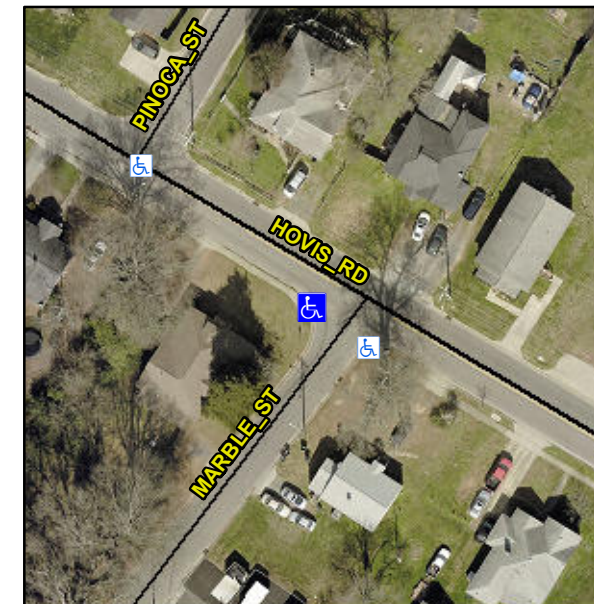
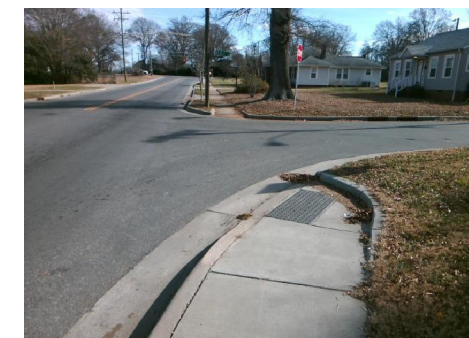
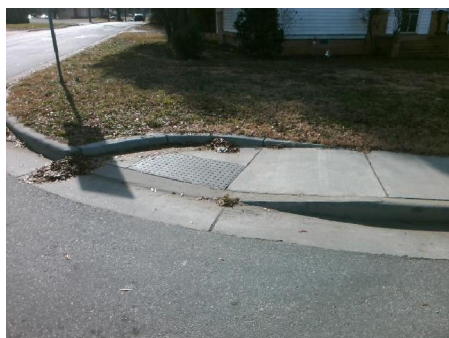
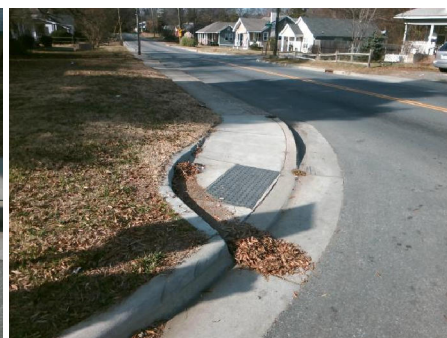
RP < 5%

Not Found, R304.5.3

Compliance	Description	Data	Compliance	Description	Data
N/A	Ramp Length LT (in)	N/A	N/A	Ramp Length RT (in)	55.0
N/A	Ramp Width LT (in)	N/A	Yes	Ramp Width RT (in)	50.0
N/A	Ramp Slope LT (%)	N/A	Yes	Ramp Slope RT (%)	5.7
N/A	Ramp XSlope LT (%)	N/A	No	Ramp XSlope RT (%)	3.9
N/A	Ramp Length (in)	36.0	Yes	Ramp Slope (%)	1.7
Yes	Ramp Width (in)	48.0	Yes	Ramp XSlope (%)	2.0
N/A	Flare Type LT	N/A	N/A	Flare Type RT	N/A
N/A	Flare Slope LT (%)	N/A	N/A	Flare Slope RT (%)	N/A
N/A	Flare Traversable LT?	N/A	N/A	Flare Traversable RT?	N/A
N/A	Landing Length (in)	N/A	N/A	DWS Provided?	N/A
N/A	Landing Width (in)	N/A	N/A	DWS Contrast?	N/A
N/A	Landing Slope (%)	N/A	N/A	DWS Length (in)	N/A
N/A	Landing X Slope (%)	N/A	N/A	DWS Full Width?	N/A
N/A	Landing Curb? (Y/N)	N/A	N/A	DWS Offset (in)	N/A
N/A	Shared Landing?	N/A			
N/A	Gutter Ponding?	N/A	N/A	Gutter Slope (%)	N/A
N/A	Gutter Lip Ht (in)	N/A	N/A	Gutter X Slope (%)	N/A
N/A	Painted X Walk1?	No	N/A	Painted X Walk2?	N/A

X Walk 1 Direction	To SE		X Walk 2 Direction	N/A
	X Walk 1 Width (in)	N/A		X Walk 2 Width (in)	N/A
	X Walk 1 Slope (%)	1.1		X Walk 2 Slope (%)	N/A
	X Walk 1 X Slope (%)	0.1		X Walk 2 X Slope (%)	N/A
N/A	Ramp inside XWalk1?	N/A	N/A	Ramp inside XWalk2?	N/A
	Road Slope (%)	N/A		Clear Space?	N/A
	Road X Slope (%)	N/A	N/A	Clear Space to XWalk (in)	N/A
			N/A	Any Obstruction?	N/A
				Obstruction Type	N/A
			N/A	Storm Grate/Utility Hazard?	N/A
				Storm Grate/Utility Type	N/A
Yes	Surface Condition? (G/P)	Good			
	Curb Slope (%)	18.5

Remove & Replace Entire Ramp.
