# Access Compliance Report

## Public Rights-of-Way

### (Curb Ramps)

Intersection ID: 31699	Main Street: TIMBERTOP_LN	Cross Street: TIMBERTOP_LN	Location: SW
ADA ID: 15C3FE9F631F	Ramp Type: PerpDiag	Initial Pass/Fail: Fail	Overall Compliance: No
Severity Score: 33.75			
Codes/Mitigation Info/Possible Solution		Field Measurements/Component Compliance

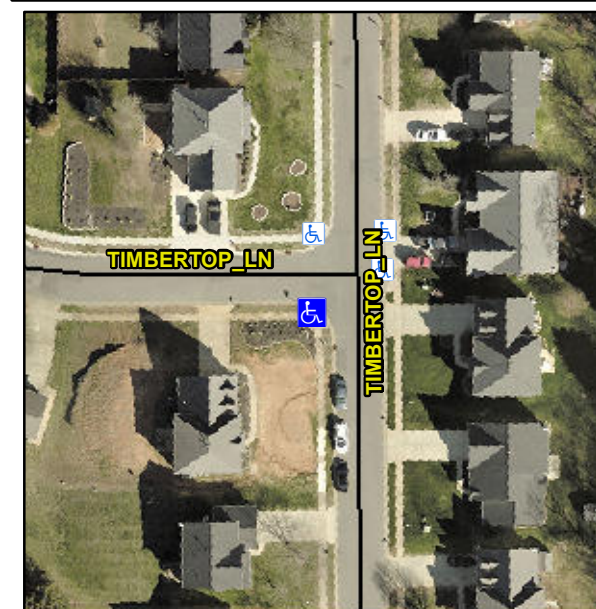
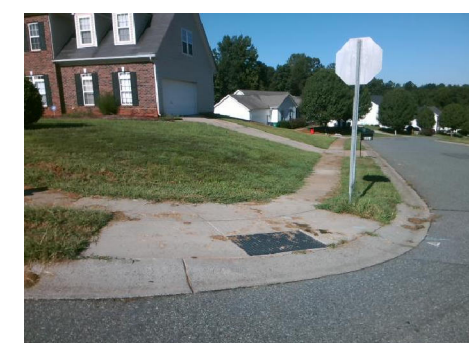
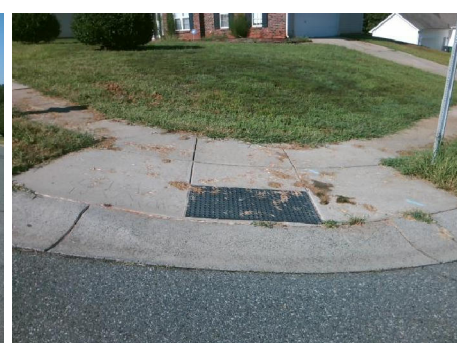
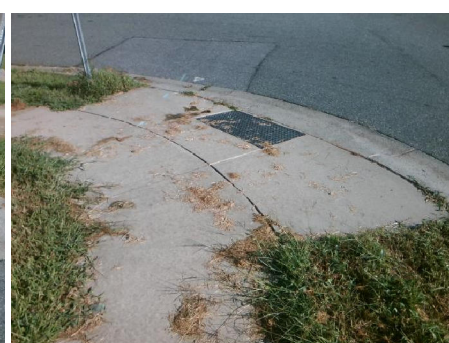
**Not Found, R304.5.1, R304.5.3**

Compliance	Description	Data	Compliance	Description	Data
N/A	Ramp Length (in)	51.0	Yes	Ramp Slope (%)	7.1
No	Ramp Width (in)	47.5	No	Ramp XSlope (%)	13.2
N/A	Flare Type LT	N/A	N/A	Flare Type RT	N/A
N/A	Flare Slope LT (%)	N/A	N/A	Flare Slope RT (%)	N/A
N/A	Flare Traversable LT?	N/A	N/A	Flare Traversable RT?	N/A
N/A	Landing Length (in)	N/A	N/A	DWS Provided?	N/A
N/A	Landing Width (in)	N/A	N/A	DWS Contrast?	N/A
N/A	Landing Slope (%)	N/A	N/A	DWS Length (in)	N/A
N/A	Landing X Slope (%)	N/A	N/A	DWS Full Width?	N/A
N/A	Landing Curb? (Y/N)	N/A	N/A	DWS Offset (in)	N/A
N/A	Shared Landing?	N/A			
N/A	Gutter Ponding?	N/A	N/A	Gutter Slope (%)	N/A
N/A	Gutter Lip Ht (in)	N/A	N/A	Gutter X Slope (%)	N/A
N/A	Painted X Walk1?	No	N/A	Painted X Walk2?	No
	X Walk 1 Direction	To E		X Walk 2 Direction	To N
N/A	X Walk 1 Width (in)	N/A	N/A	X Walk 2 Width (in)	N/A
	X Walk 1 Slope (%)	4.8		X Walk 2 Slope (%)	2.5
	X Walk 1 X Slope (%)	5.1		X Walk 2 X Slope (%)	7.6

N/A	Ramp inside XWalk1?	N/A	N/A	Ramp inside XWalk2?	N/A
	Road Slope (%)	10.5	N/A	Clear Space?	N/A
	Road X Slope (%)	2.2	N/A	Clear Space to XWalk (in)	N/A
N/A	Any Obstructions?	N/A	N/A	Storm Grate/Utility Hazard?	N/A
	Obstruction Type			Storm Grate/Utility Type	
		N/A			N/A
			Yes	Surface Condition? (G/P)	Good

Possible Solutions:

**Remove & Replace Curb Ramp With Two New Directional Ramps or Equivalent.**
