# Access Compliance Report

## Public Rights-of-Way

### (Curb Ramps)

| Intersection ID: 53918 | Main Street: VISTA_WOODS_LN | Cross Street: BRITTONDALE_LN | Location: E |

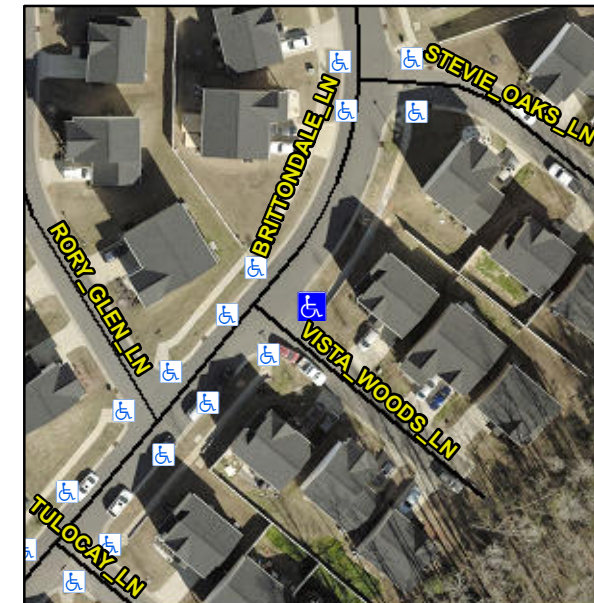
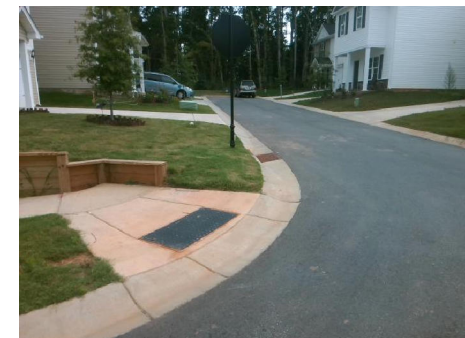
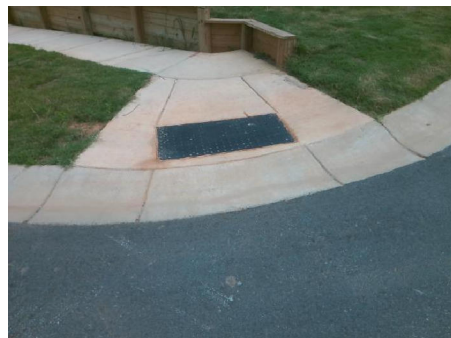
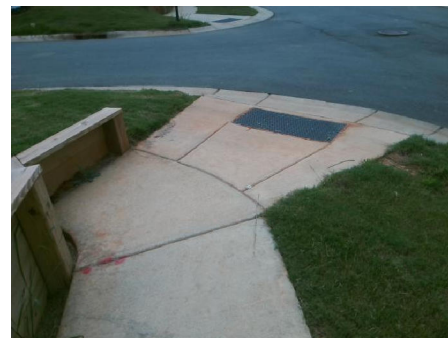
| ADA ID: 15D238CC3580 | Ramp Type: BlendTrans1 | Initial Pass/Fail: Fail | Overall Compliance: No |

**NO RT SW**

**Not Found, R304.5.1, R304.5.3**

| Compliance | Description | Data | Compliance | Description | Data |
|---|---|---|---|---|---|
| No | Ramp Width (in) | 31.5 | No | BlendTrans XSlope (%) | 3.8 |

**Remove & Replace Curb Ramp With Two New Directional Ramps or Equivalent.**
