# Access Compliance Report

## Public Rights-of-Way

### (Curb Ramps)

| Intersection ID: 17802 | Main Street: HAVEN_DR | Cross Street: REECE_RD | Location: SE |

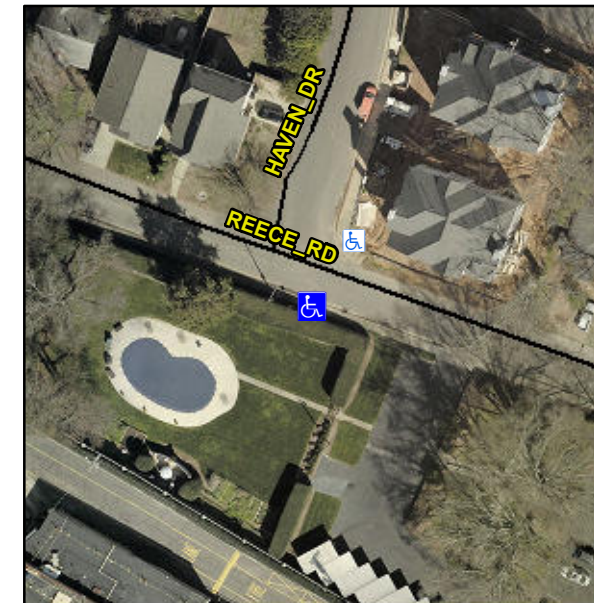
**Not Found, R304.2.1, R302.7, R302.7.2, R304.5.4**

| Compliance | Description | Data | Compliance | Description | Data |
|---|---|---|---|---|---|
| No | Landing Length (in) | 23.0 | Yes | DWS Provided? | Yes |
| No | Landing Width (in) | 46.0 | Yes | DWS Contrast? | Yes |
| No | Gutter Ponding? | Yes | No | Gutter Slope (%) | 7.4 |
| No | Gutter Lip Ht (in) | 1.0 | Yes | Gutter X Slope (%) | 0.2 |
| | | | No | Curb Slope (%) | 14.8 |

**Remove & Replace Curb Ramp With Two New Directional Ramps or Equivalent. Remove & Replace Gutter.**
